**OFFICE OF THE SPECIAL INSPECTOR GENERAL  
FOR AFGHANISTAN RECONSTRUCTION**

**INSPECTION OF ABDUL MANAN SECONDARY SCHOOL  
CONSTRUCTION PROJECT IN KAPISA PROVINCE:  
INSUFFICIENT PLANNING, SAFETY PROBLEMS, AND POOR  
QUALITY CONTROL AFFECT PROJECT RESULTS**

October 26, 2009

SUBJECT: SIGAR Inspection Report 10-2: Inspection of Abdul Manan Secondary School Construction Project in Kapisa Province: Insufficient Planning, Safety Problems, and Poor Quality Control Affect Project Results

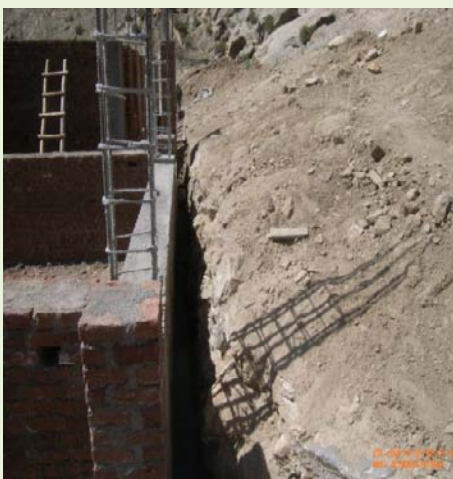
The photo at left shows the rear wall of the school structure constructed adjacent to the vertical wall of the excavation, leaving no room for the security perimeter wall. Contrary to accepted construction practices, the contractor was forced to excavate the area around the wall after it was built.

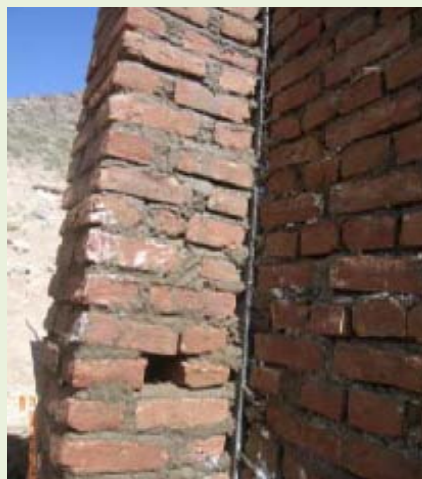
The photo at the right is an example of substandard masonry work which had to be demolished and rebuilt. (Photos provided by SIGAR)

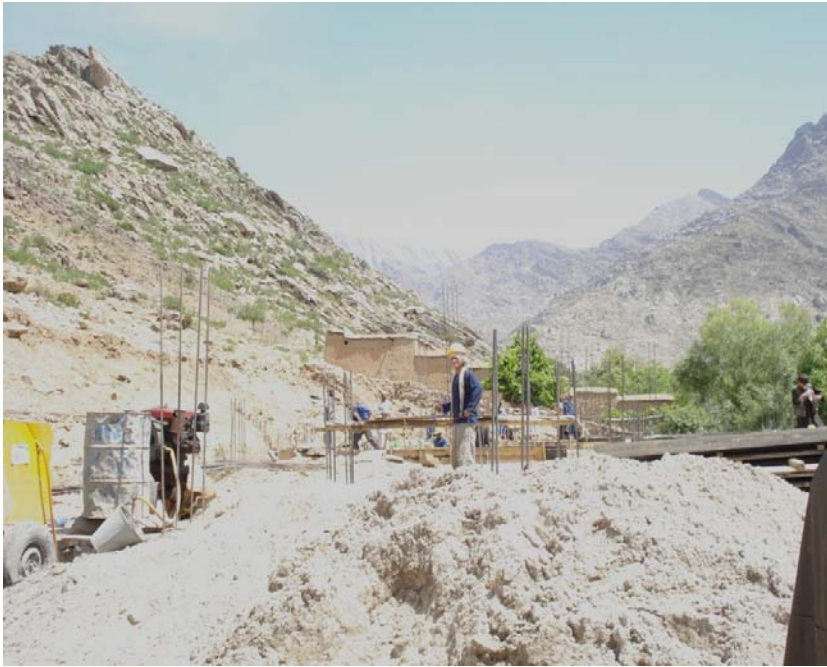
**Site Photo 1: View of the challenging terrain where the Abdul Manan School is being constructed. Extensive grading work was required at this site prior to construction. (Photo provided by SIGAR)**

The location for the school compound was chosen because it was unused government land but it is far from ideal for construction work. In discussions with the Provincial Director of Education, SIGAR was told that this was the only parcel of land in the community that was available to place the school. At an elevation of nearly 6,000 feet and located on the side of a bare mountain, the site is positioned approximately 200 meters up the side of a steep slope in an area prone to rock and mud slides. In order to prepare the site for construction, an access road had to be built and extensive excavation work that included cutting a level shelf off the side of the mountain had to be performed.

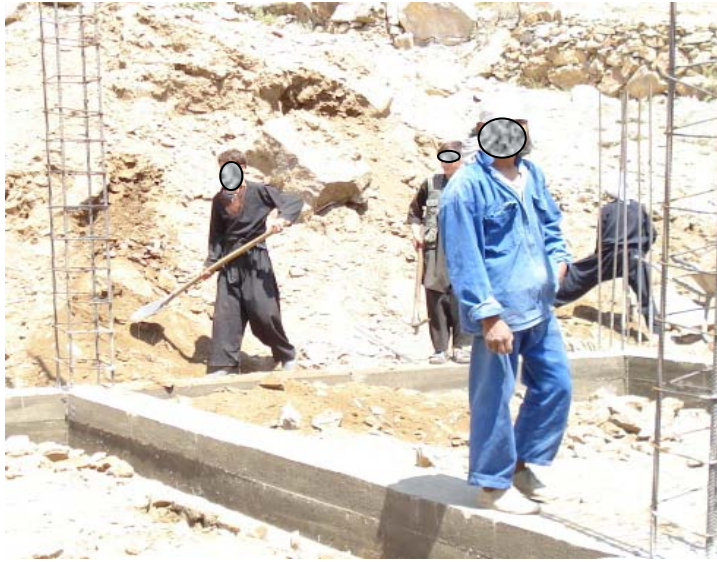
SIGAR also found that although the contractor made extensive mention of safety requirements for his workers in the project work plan, numerous safety violations were noted by SIGAR. These violations included workers without head, eye, hand, or foot protection. (See Site Photo 2)

**Site Photo 2: Laborers working on the project with no personal protective equipment such as hardhats, gloves or, in some cases, even shoes. (Photo provided by SIGAR)**

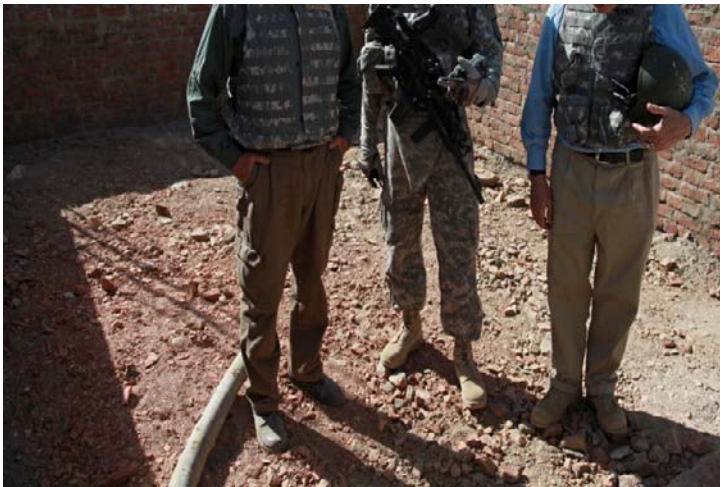
**Site Photo 3: View of SIGAR inspectors with the PRT Quality Assurance Representative examining completed work. SIGAR found that the floor of the room had not been compacted to prepare it for the concrete slab-on-grade. (Photo provided by SIGAR)**

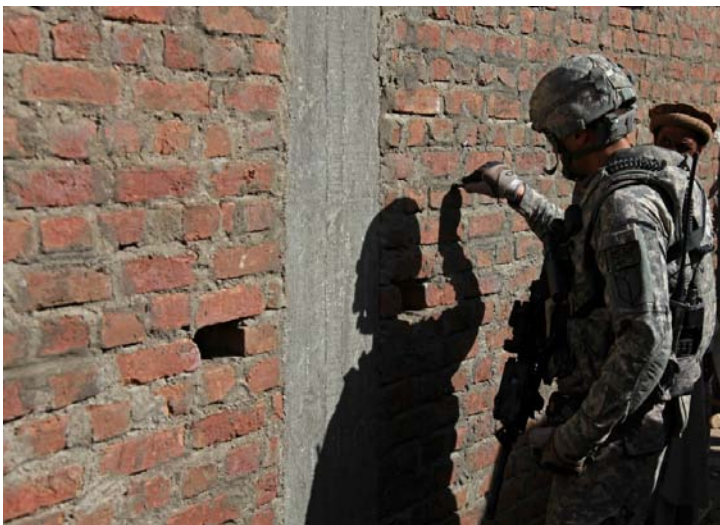
**Site Photo 4: View of PRT Quality Assurance Representative testing the mortar work for durability. Such testing is critical to assess if the materials used meet the standards specified in the statement of work. In the case that materials do not meet these standards, the Quality Assurance Representative can order the contractor to redo the work which might involve tearing down already constructed sections of the project. (Photo provided by SIGAR)**

This lack of quality control documentation was reflected by a lack of consistent performance and construction methods that had to be corrected late in the project life cycle. Examples include the contractor stating he was ready to pour concrete into the floors of rooms that had not yet been properly compacted (see Site Photo 3) and the PRT Quality Assurance representative having to direct several portions of completed brick work to be demolished due to use of improper mortar mixture in their construction (see Site Photo 4).
