SIGAR Inspection 13-2

**WARDAK PROVINCE NATIONAL POLICE
TRAINING CENTER: CONTRACT
REQUIREMENTS GENERALLY MET, BUT
DEFICIENCIES AND MAINTENANCE ISSUES
NEED TO BE ADDRESSED**

**OCTOBER
2012**

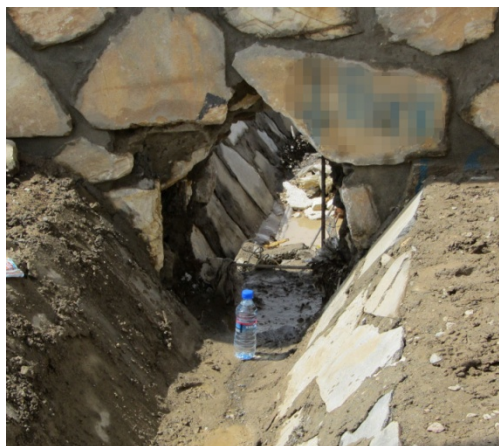
Missing Grate Could Allow Unauthorized Access

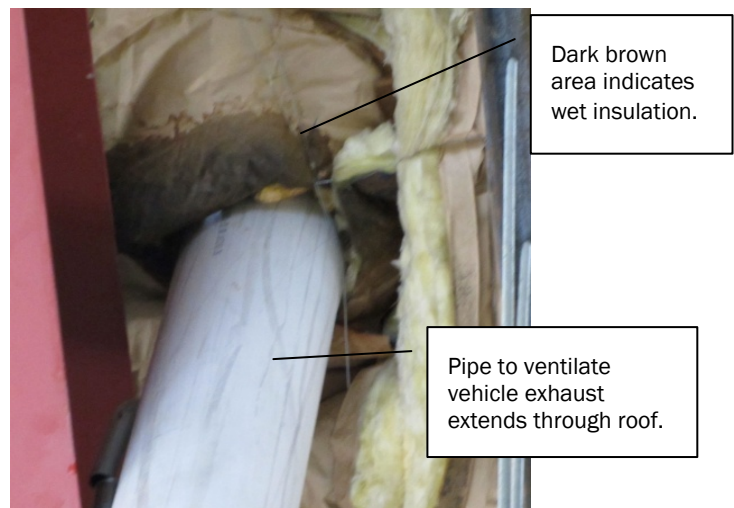
Construction quality at the vehicle maintenance building generally met contract specifications; however, we observed some minor deficiencies. This facility is a pre-engineered (steel frame with steel roof) building with six maintenance bays, two of which had maintenance pits for easier access to vehicle undercarriages. Contractor personnel were being used to assist the ANP with vehicle maintenance. We observed that 3 of the 6 bays were occupied, and work was ongoing with various vehicle repairs. However, the building had minor roof leaks around the pipes used to carry vehicle exhaust out of the building, as shown in figure 1, and we observed standing water on the floor as a result of these leaks.

Figure 1 - Roof Leakage with Wet Insulation at Vehicle Maintenance Building

- 2. Repair roof leaks around the vehicle exhaust ventilation pipes in the vehicle maintenance building.**

Concur. USACE-TAN conducted joint final inspections on 9 May 12, determined that construction was substantially complete, and provided SIGAR with a copy of the Administrative Contracting Officer's certification of same, dated 29 Jun 12, and a Resident Management System (RMS) report, dated 12 Sep 12, showing construction status. To ensure corrective actions taken were adequate to prevent further leaks, USACE/TAN is also notifying the O&M contractor and the COR to verify the roof has been repaired and isn't leaking.

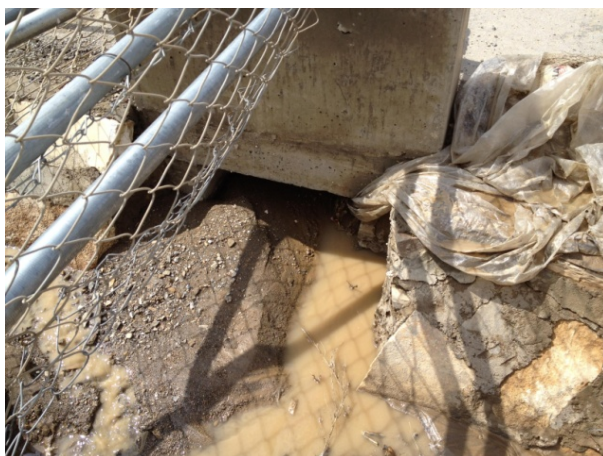
During our site visit, we also observed that some storm water ditches had construction debris and sediment and needed to be cleaned. Near the NPTC storm water discharge point, one ditch was almost completely blocked with sediment (see figure 2). From the amount of sediment observed, it is likely these deposits were the result of several storms. The accumulated sediment and debris caused the storm water ditch to overflow, resulting in flooding and sediment buildup. In addition, a missing storm water grate at the perimeter wall is a security concern (see figure 3), because it is large enough to allow a person to crawl through and gain unauthorized access to the compound.

Figure 2 - Storm Water Ditch Clogged with Sediment

4. Regularly clean silt and construction debris from the storm drain system.

Concur. The O&M contract COR is verifying the current condition of the drainage areas and structures. Additionally the COR will request that the O&M contractor routinely check all drainage structures, ditches, debris removal, and appurtenances as part of their routine monthly preventative maintenance inspection. As storm events occur and conditions on the site continually change, the contractor will conduct frequent review/survey of the site for conditions such as those observed during the SIGAR visit, and the responsible contract COR will verify the actions taken.

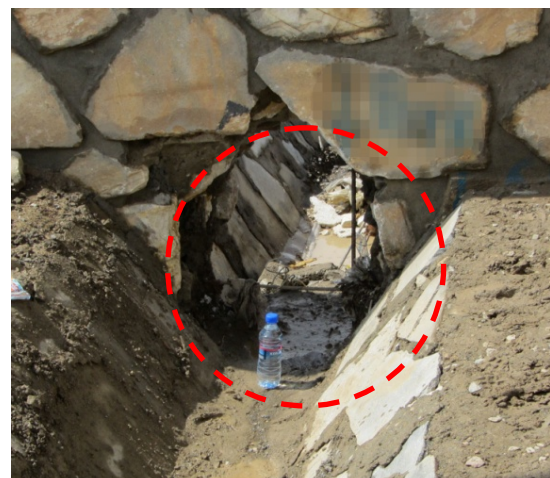
Figure 3 - Storm Water Ditch Missing Security Grate

3. Repair the missing storm water outlet grating in the perimeter wall, which could enable a person to gain unauthorized access to the compound.

Concur. USACE/TAN has requested the O&M contract COR verify the current condition of drainage areas and structures to ensure any missing storm water outlet grating is replaced.
