**SIGAR Inspection 13-3**

## **GAMBERI AFGHAN NATIONAL ARMY GARRISON: SITE GRADING AND INFRASTRUCTURE MAINTENANCE PROBLEMS PUT FACILITIES AT RISK**

**OCTOBER  
2012**

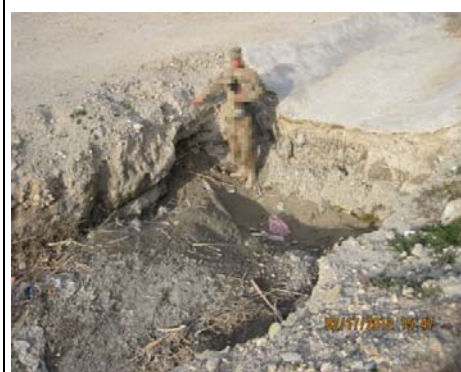
Storm  
Drain  
Erosion

Failure to mitigate site grading issues and inadequate storm drainage maintenance continue to threaten facilities at the Gamberi ANA garrison. Poor site grading resulted in areas of low elevation where storm water collected, causing flooding within the garrison and allowing sediment to collect and storm water ditches to erode. SIGAR observed an eroded channel and standing water by the wastewater treatment plant. Due to the amount of erosion, debris, and signs of flooding, SIGAR observed that USACE had done little to prevent or repair these problems, and its site grading efforts had been ineffective. Should flooding continue, it could eventually damage roads and affect wastewater treatment plant operation by preventing access to the facility, overflowing into the treatment plant, and weakening building foundations, which could cause the buildings to become unsafe or unusable.

SIGAR recommends that the Commanding General, USACE, to (1) repair damaged storm water facilities, (2) implement mitigating flood control measures, (3) maintain the storm water drainage system, and (4) review the culvert's design and correct any deficiencies identified. USACE-TAN concurred with the first three recommendations and noted actions it is taking to address them. USACE disagreed with the fourth recommendation but plans to inspect the culvert during the warranty period and correct any deficiencies identified.

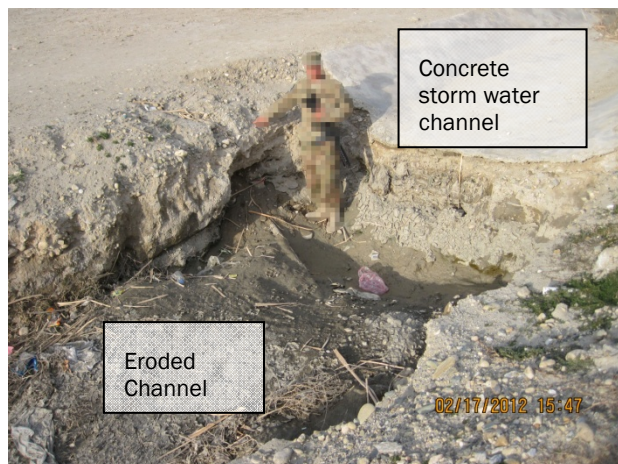
**Figure 1 - Eroded Channel**

During this inspection, we also observed a channel with erosion of 2,000 mm to 3,000 mm deep (see figure 1) and standing water by the wastewater treatment plant (see figure 2). Due to the amount of erosion, debris, and signs of flooding that we observed, we concluded that USACE had done little to prevent or repair these problems, and its site grading efforts had been ineffective. Poor infrastructure maintenance may have also contributed to garrison flooding, erosion around the storm water channels, and debris blocking water outlets at the perimeter wall and storm drain culverts.

1. Repair damaged storm water facilities by repairing eroding ditches and removing sediment and debris on roads, in ditches, and in perimeter wall outlets throughout the garrison.
2. Implement mitigating flood control measures, such as adding gravel to low lying roads where flooding regularly occurs to drain these areas more quickly.
3. Establish and follow a program to maintain the storm water drainage system and ensure that timely repairs are made to correct the deficiencies that we identified.
4. Conduct a detailed structural analysis and design review of the culvert design package and take appropriate actions to correct any deficiencies identified.

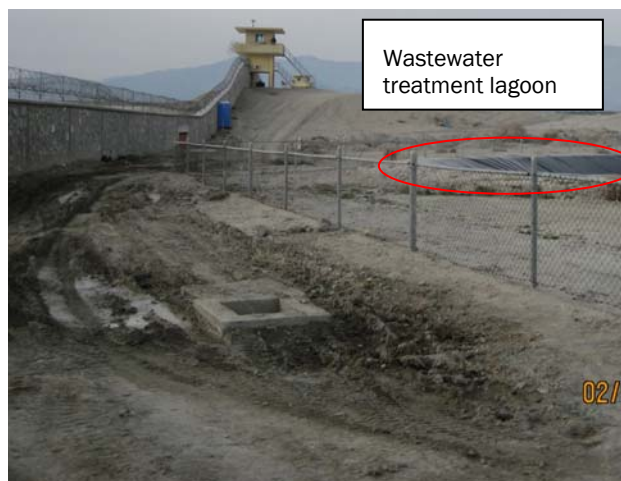
**Figure 2 - Perimeter Road**

We also noted that the wastewater treatment plant, located in the south corner of the garrison (downhill from the rest of the base), was prone to flooding because of improper site grading. As a result, travel in the area was difficult or impossible during flooding conditions. We found no evidence that grading or appropriate structures had been put in place to divert the storm water off site. Further, we noticed severe erosion occurring in the storm water channels in this area, as well as water collecting in the low-lying areas, when it should have drained into channels leading outside the base, especially near the wastewater treatment plant. There was no evidence that any work had been conducted to repair this issue.<sup>11</sup> Should flooding continue, it could eventually affect wastewater treatment plant operation by preventing access to the facility, overflowing into the treatment plant, and weakening building foundations, eventually causing structural failures.
