SIGAR 16-16 Inspection Report

Afghan Ministry of Defense Headquarters:
\$154.7 Million Building Appears Well
Built, but Has Several Construction Issues
that Should Be Assessed

FEBRUARY
2016

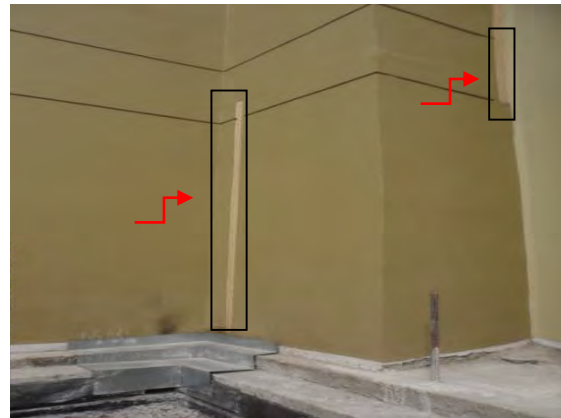
- Not all of the separation joints were aligned vertically from the foundation up to and through the roof of the building, as the contract design documents required (see photos 1 and 2 showing that the separation joints are not continuous.) As a result, the seismic calculations used are not valid. Most significantly, a structural failure of the concrete frame could result in occupants being harmed and the affected areas being rendered unusable until repairs are made. We requested Quality Assurance/Quality Control reports and photographs from AFCEC for the period of the concrete pour and form removal of specific areas. However, we did not receive the reports or photographs for the separation joints that concerned us.

Photo 1 - Separation Joint Is Not Continuous: This Joint Ends at Top of the Third Floor, and Resumes at a Different Point on the Fourth Floor

1. Assess the building's structural integrity where separation joints are not a continuous line from the bottom to the top of the building and the allowable building movement exceeds standards, and if needed, make deficient areas structurally sound.

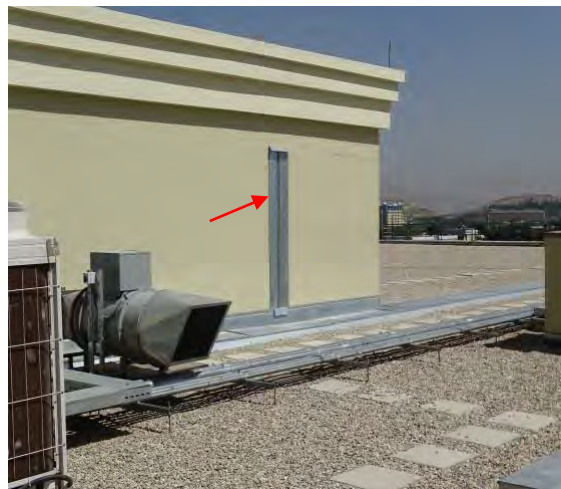
Photo 2 - Separation Joint Is Not Continuous at Top

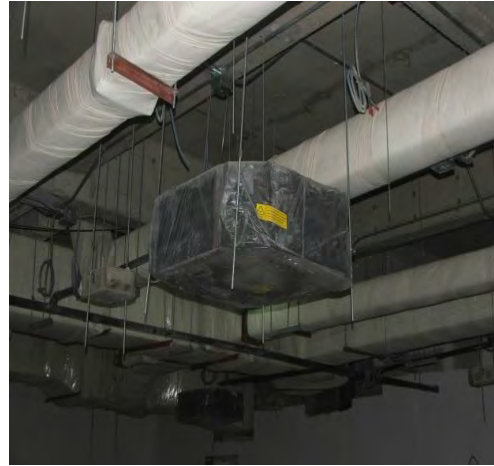
Photo 3 shows a ceiling-mounted piece of heating/cooling equipment and mechanical duct work with no lateral bracing. In addition, the fuel supply for the fire suppression pump in the basement was installed without lateral bracing, isolation joints, or containment.⁶ In a seismic event, the elevated 238-gallon diesel fuel tank could spill fuel across the pump room floor. The fuel would then leak into the rain water collection system, be directed to the wastewater treatment plant, and ultimately discharged into the Kabul River.

Photo 3 - Ceiling-Mounted Equipment and Mechanical Duct Work With No Lateral Bracing

2. Assess the need for the installation of seismic lateral bracing on non-structural components suspended from the ceiling or floor above, such as heating/cooling equipment, duct work, dropped ceilings, electrical fixtures, and drain pipes.

4. Assess the integrity of lateral bracing, anchorage, isolation, and energy dissipation of all equipment for compliance with the contract's seismic requirements, and make deficient items compliant with the requirements.

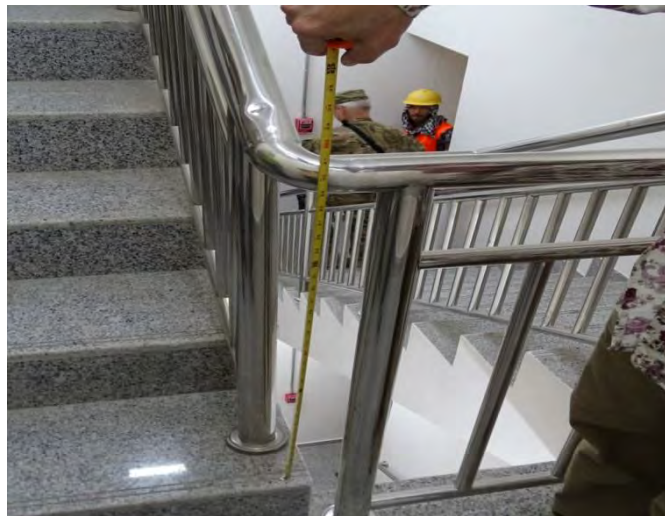
We found that the handrails on interior stairways were not installed at the proper height. During our May 27, 2015, site inspection, we measured the handrail height at 31 inches, which does not meet the minimum 34-inch height required by the International Building Code (see photo 4 showing the lower than required handrail height).¹² The 34-inch handrail height is standardized to allow the average person to reach for the handrail at an average height, so a lower height could contribute to falls on the stairways and injuries.

We also found that the handrail material was insufficient in quality. Our review of construction documents showed that the originally specified handrail material was mild steel pipe, but that AFCEC approved ITSI's request to substitute stainless steel thin-

Photo 4 - Handrail Is 31 Inches in Height and Is Dented

walled pipe.¹³ The walls of the stainless steel pipe are no more than a fourth as thick as the originally required pipe. As a result, we found that the installed handrail has multiple dents, which is common for stainless steel thin-walled pipe. The substitution to the thin-walled stainless steel pipe will result in increased maintenance costs for the handrails, which run the risk of being dented further when furniture is moved into the building.

Our draft report included a sixth recommendation for CSTC-A to address the defective handrails. In its comments, CSTC-A informed us that Gilbane Federal corrected the height of the handrails in November 2015. We confirmed during our post-earthquake inspection on January 7, 2016, that CSTC-A acted on the recommendation and corrected the handrails. Therefore, we did not repeat the sixth recommendation in our final report.
