SIGAR 16-26 Inspection Report

### Afghan Air Force University: Contract Requirements Were Generally Met, but Instances of Non-Compliance, Poor Workmanship, and Inadequate Maintenance Need to Be Addressed

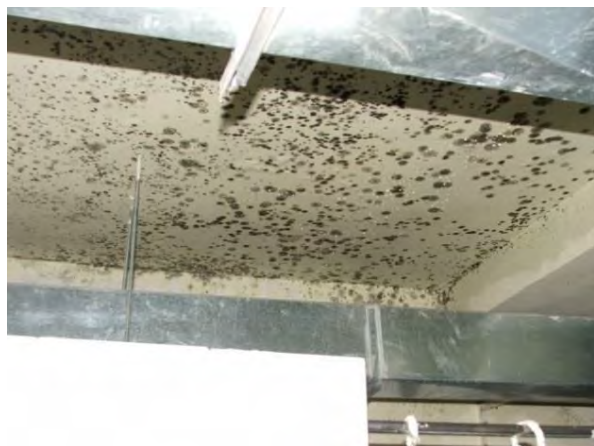
We also found that 2 of the 10 buildings that USACE transferred to Afghan authorities in April 2015 were not being used. Agency officials explained that no furniture had been moved into barracks Nos. 1 and 4 because Afghan authorities discovered multiple problems, including plumbing leaks in the bathrooms, broken sinks and fixtures, and non-functioning ceiling fans. In addition, during our inspection, we found other problems with various buildings that can mostly be attributable to inadequate maintenance by the Afghan government, including mold growth, filthy bathroom conditions, broken door locks, and broken or missing plumbing fixtures. Photos 1 and 2 show examples of mold and poorly maintained bathrooms, respectively.

**Photo 1 - Mold Growth in Bathroom Building 7a**

We conducted a review and will ensure that items still under warranty do not appear on the Statement of Requirements list. To note, the Statement of Requirements includes non-warranty mold remediation which is due to leaking supply and drain pipes in the barracks buildings and a lack of maintenance in these buildings.

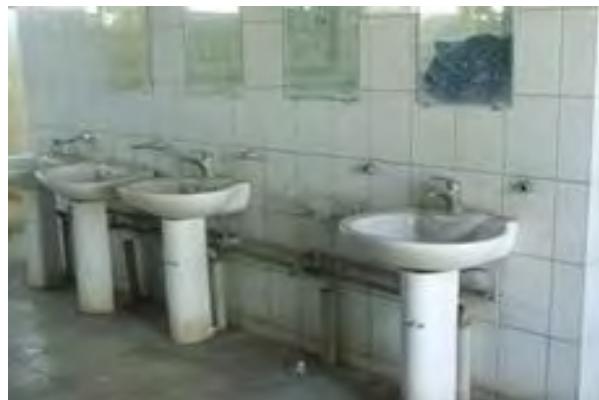
At the time of our March 2015 site visit, we found that the four bathroom buildings transferred to Afghan authorities in April 2014 were not being used. However, according to USACE officials, these four buildings are now being used by Afghan students and staff, despite the fact that a number of sinks and faucets are broken, some light bulbs are burned out, and the water heaters are not functioning.

**Photo 2 - Poorly Maintained Facilities in Bathroom Building 7**
