SIGAR 17-03 Inspection Report

**Special Mission Wing Facilities at Kandahar Airfield:
Construction Generally Met Contract Requirements,
but Problems with Noncompliance, Maintenance,
and Quality Assurance Need to be Addressed**

OCTOBER
2016

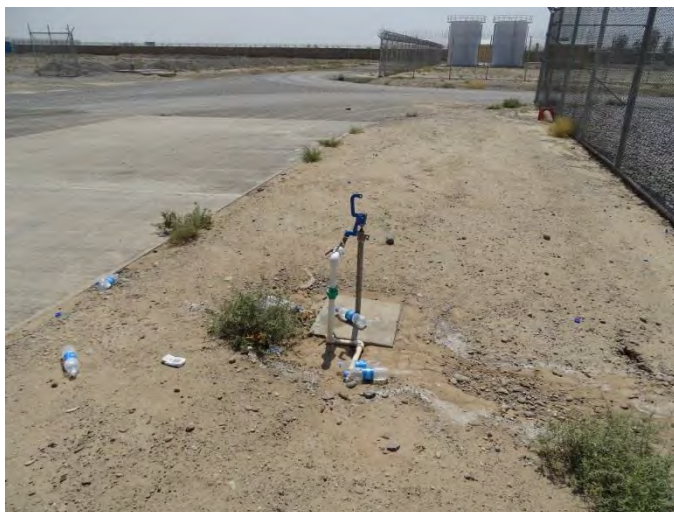
Photo 1 - Improperly Constructed Vehicle Wash Rack

- **Improperly constructed the vehicle wash rack:** The contract required ECC to construct the foundations, mountings, pumps, wash stations, equipment configurations, and a chain link security fence for the vehicle wash rack. In addition, each vehicle wash station was required to have water supply piping with valve boxes, concrete pads with vehicle barriers and trench drains, light towers, cleanup hydrants with hose connections, and lighting.¹¹ ECC also was required to build a wastewater treatment facility for the vehicle wash rack. Although ECC also constructed a wash rack, it only consisted of one concrete pad, a yard hose bib, and an unfinished power cabinet along a gravel road outside the motor pool fence (see photo 1).¹² None of the required hoses, lighting, trench drains, fencing, or wastewater treatment infrastructure were located during the site visits. According to transfer documents, the wash rack cost approximately \$78,000.

USACE did not concur with our recommendation to pursue a refund from ECC for the vehicle wash rack with all required features that the command paid for but did not receive, stating that ECC built the vehicle wash rack in accordance with contract requirements. USACE stated that the standard design drawings depict a concrete slab for the wash rack, and the wash rack was constructed in compliance with typical Afghanistan National Defense and Security Forces construction standards, which USACE used with CSTC-A's concurrence. We disagree with USACE. The additional features are specifically identified in section 01015-6.11 of the site-adapt project specifications, and ECC did not provide those features. Further, the design drawings do not remove the requirements identified in the site-adapt project specifications. As a result, the recommendation remains open until USACE receives a refund the required features that it paid for, but ECC did not install, at the vehicle wash rack.

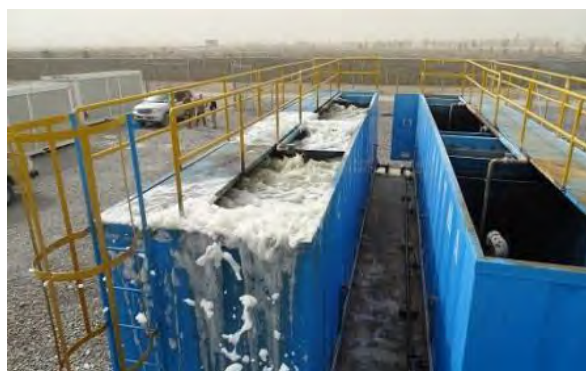
Photo 2 - Wastewater Treatment Plant with One Functioning Tank

- ECC constructed the wastewater treatment plant as required. Although the treatment plant has two treatment tanks, during our site visits, we observed that only one of the two tanks was functioning. As a result, the operating tank was producing excessive amounts of white foam that breached its sides and spilled onto the ground (see photo 2). Excessive white foam indicates that the water is not being treated effectively, and the water could be a health hazard when it is discharged from the plant. The treated

USACE did not concur with our recommendation to repair the wastewater treatment plant's non-working tank and ensure the plant is fully operational, stating that the wastewater treatment plant was properly constructed with two water tanks, in accordance with contract specifications. USACE stated the complex was not yet at full capacity, with only 167 out of 400 individuals on site, and speculated that the second tank was operational but not operating because there was no need for it. However, during our July 2015 and February 2016 site visits, we found that the second tank was not operational because it was in disrepair, and the overflow in the first tank was creating an environmental hazard. We believe that this is a maintenance issue, rather than an ECC failure. However, the recommendation to CSTC-A remains open until we receive evidence that the non-operational water tank is repaired to prevent an environmental hazard caused by the overflow of the first water tank.

d. Repair the wastewater treatment plant's non-working tank and ensure the plant is fully operational. Non-Concur. The waste water treatment plant was constructed with two water tanks in accordance with contract specifications, which was designed to handle 400 individuals. At the time of this review there were 167 individuals at the complex, or 40% of full capacity. Both tanks were fully operational when commissioned and the facility was turned over to our customer on September 30, 2014. It is possible the second tank remains operational but not operating because of the lack of need. Neither ECC nor USACE has the responsibility for operations and maintenance of the facility.

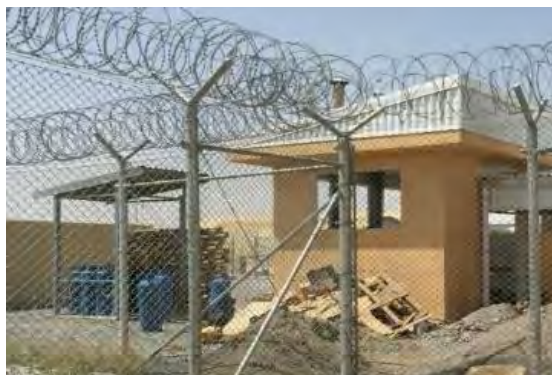
Photo 3 - Propane Tanks Stored Too Close to the Cooking Building

- ECC constructed a storage yard adjoining the dining facility, as required. The yard was fully graveled and fenced, and was designed to store supplies for the dining facility. During our inspection, we observed piles of combustible material—including wood, paper, and other debris—and what SMW officials stated were empty propane tanks on the ground outside of the cooking building (see photo 3). The contract design drawings required propane tanks to be stored at least 26 feet from occupied buildings, but we found that the tanks were stored within 15 feet of the cooking building. Storing the propane tanks so close to the cooking building with combustible material creates a safety hazard.

USACE did not concur with our recommendation to remove the propane tanks and combustible materials near the cooking building, stating that the site was clean and all propane tanks were securely and safely stored under the storage sunshade at the time it transferred the facilities to CSTC-A. USACE stated that the improper storage of the tanks is an operations and maintenance issue. We agree. However, during our inspection, we identified the improper storage of the propane tanks—stored too close to the cooking building—as a safety

hazard (see photo 3 on page 6). As a result, the recommendation to CSTC-A remains open until we receive evidence that all propane tanks are stored the proper distance from the cooking building.

b. **Remove the propane tanks and combustible materials near the cooking building. Non-Concur.** The condition that SIGAR found at the site as described in the SIGAR report and shown in the photograph in the report is a result of improper facility operations and maintenance. All required specifications to the contract were met. USACE considers this recommendation an operations and maintenance issue with responsibility belonging to the facility user. The photograph below shows the site when USACE turned it over to the customer. The site was clean and all propane tanks were securely and safely stored under the storage sunshade. Whatever occurred after transfer of the project to the customer that lead to the conditions SIGAR found is not the responsibility of USACE or the USACE construction contractor.

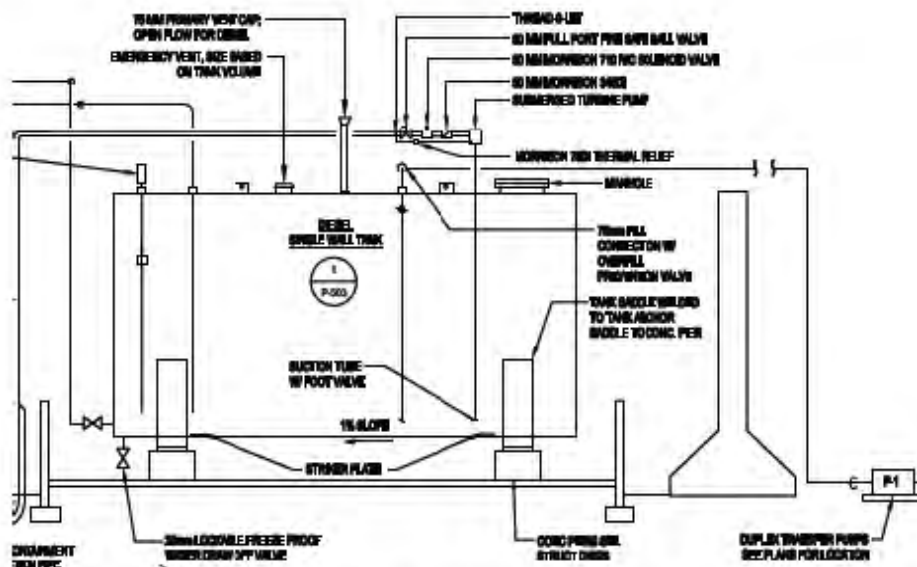
c. Install the water draw off lines in the power generation plant. Non-Concur. The contractor properly constructed the power generation plant in accordance with contract drawings and specifications. The 100% design drawings, shown below, for the fuel tanks, indicate the location of the installed water draw lines. The fuel tank is equipped with a freeze proof water bleed off valve that is found at the front of the tank. The tank is installed with a 1% slope to allow for draining in the direction of the valve. Section 01015, Para. 5.17.1, which is specific language for the power plant generators, has no reference to UFC 3-460-01. It is doubtful whether any of the provisions of UFC 3-460-01 are applicable since they are not specifically referenced.

The fuel tank has a freeze proof water bleed off valve at the front of the tank and it is installed with a 1% slope to drain in the direction of this valve.
