SIGAR 17-65 Inspection Report

Afghan Ministry of Interior Headquarters  
Project: Phase 2 Experienced Lengthy  
Delays, Increased Costs, and Construction  
Deficiencies that Need to Be Addressed

SEPTEMBER  
2017

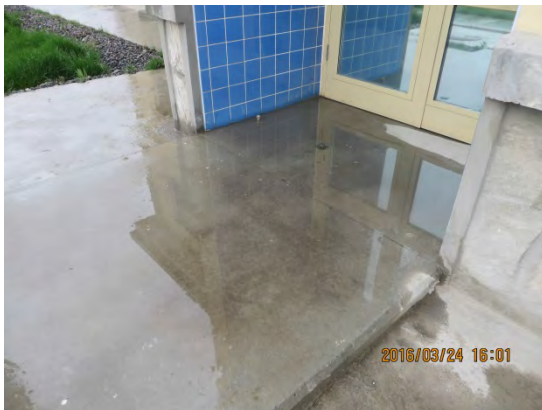
drain away from them. For example, rainwater pools in front of the main headquarters building entrance (see photo 1). Storm water also flooded communication and electrical manholes. In addition, the soil in some areas of the project site was not well compacted. For example, we found that the area around the wastewater treatment plant has settled about 50 centimeters below grade level (see photo 2). Further, we conducted soil field density tests at 10 project site locations and found that the soil density in 8 of the sites did not meet contract requirements. The contract required a density of 95 percent, and the density levels in the eight sites ranged from 70 to 94 percent. As a result, the soil at the sites will continue to erode over time and lead to unnecessary repairs. In its comments on a draft of this report, USACE stated that it was not responsible for the poorly graded and compacted soil deficiency, and that this was the result of work performed by a different contractor under a follow-on contract. We accept that an unidentified party, possibly another contractor working at the site, damaged some areas around the MOI headquarters building and that USACE's contractor, Yuksel Insaat, is not responsible for that damage. However, we found ground settlement and water pooling in areas that would not have been affected by other contractors.

**Photo 1 - Pooling Water in the MOI Headquarters Building Entrance**

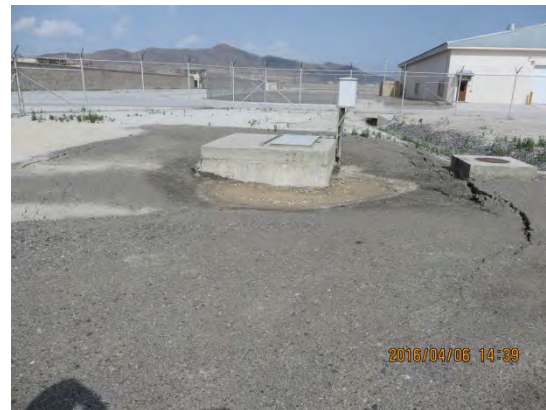
**Photo 2 - Ground Settlement and Water Pooling Around the Lift Station**
