**ANP District Headquarters Facilities in Helmand and
Kandahar Provinces Have Significant Construction
Deficiencies Due to Lack of Oversight and Poor
Contractor Performance**

SIGAR Audit-11-3

ANP District Headquarters Facilities In Helmand and Kandahar Provinces Have Significant Deficiencies Due to Lack of Oversight and Poor Contractor Performance

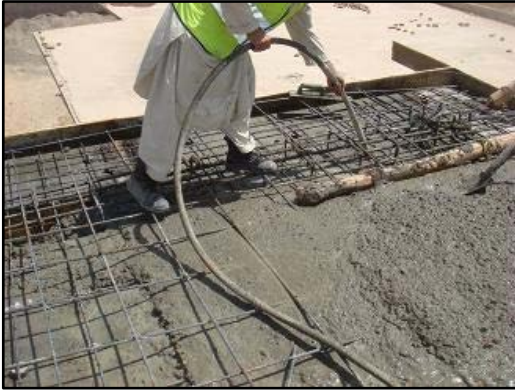
not appear to meet slump test standards, indicating weak concrete. Photo 2 shows a construction worker pouring a watery concrete mixture, not likely to meet concrete test standards, for a roof slab at one of the six sites. Photo 3 shows poor concrete at what appears to be a slab-on-grade at the Garm Ser site.

Photo 2: Placement of Watery Concrete Mix

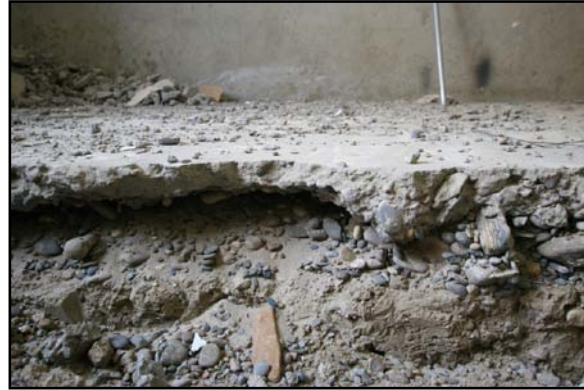
Photo 3: Poor Concrete Slab-on-Grade with No Reinforcement at Garm Ser Site

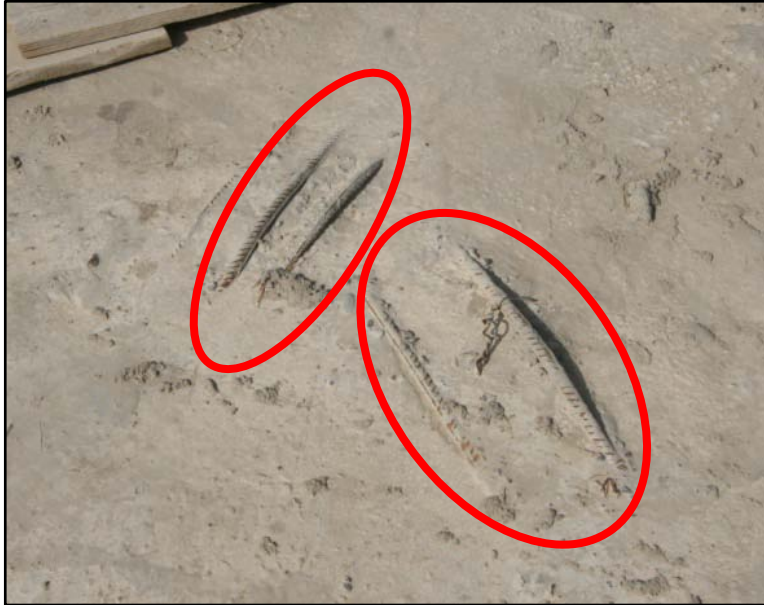
Improper installation of steel reinforcement bars within concrete work also posed a significant risk to the structural integrity of some completed buildings. The contract documents provided details on where steel reinforcement should be placed within a concrete structure. For example, on the roof slab, the contract documents indicated that two perpendicular grids of steel reinforcing bars should be placed in the top and bottom portions of the slab and covered with a minimum amount of concrete. At several locations we observed randomly placed reinforcement bars protruding through the roof slab. Randomly placed steel bars do not provide the required structural capacity for the building and exposed steel will corrode and weaken the structure. Photo 4 shows randomly placed steel reinforcement on the concrete roof slab at the Garm Ser site, in breach of contract specifications.

Photo 4: Exposed Randomly Placed Steel Reinforcing in Concrete Roof Slab at Garm Ser Site

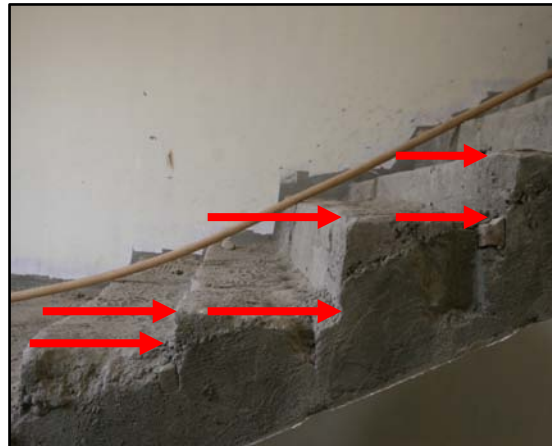
Photo 6: Crumbling Concrete Stairs of Different Heights at Garm Ser Site

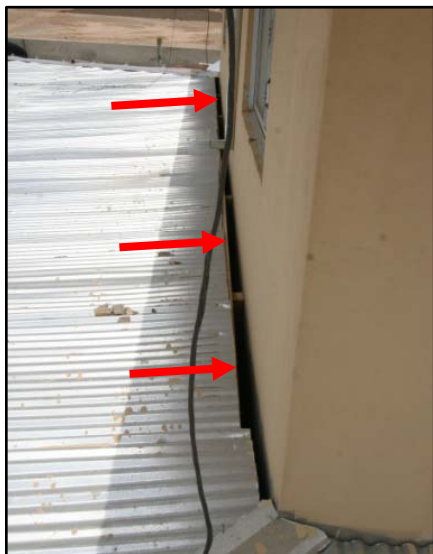
Photograph 7 shows a large gap between the metal roof and the exterior wall at Nahri Saraj that will allow water to penetrate the sub-structure. Photograph 8 shows a damaged roof panel with improperly installed flashing.

Photo 7: Gap Between Roof Panels and Exterior Wall at Nahri Saraj Site

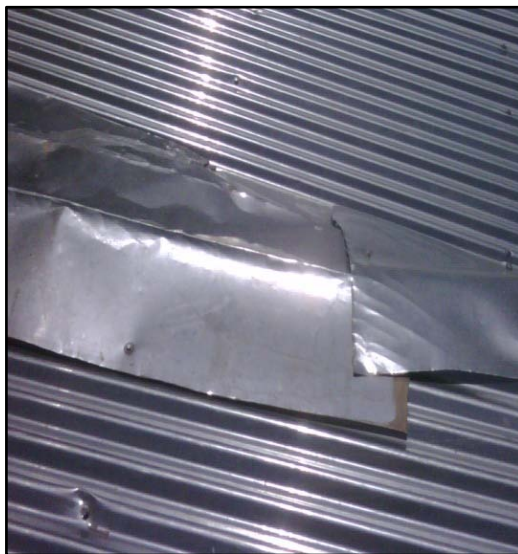
Photo 8: Damaged Roof Panels and Improper Flashing Installation at Spin Boldak Site

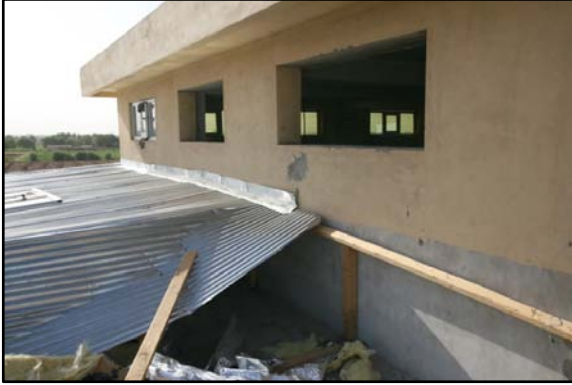
At the Nad Ali site, an ANP unit forcibly occupied the site, demolishing approximately half of the completed roof structure. The remaining portion was poorly constructed, sagging significantly when weight was applied. Photo 9 shows the partially demolished roof at Nad Ali.

Photo 9: Partially Demolished Roof at Nad Ali Site

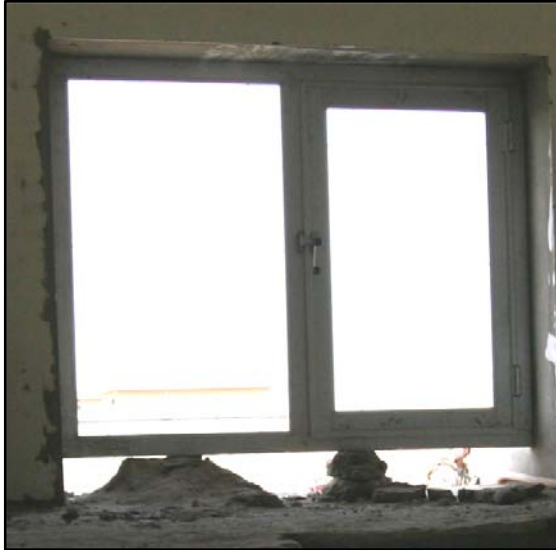
The contract requirements indicated that the windows in the headquarters buildings should be commercial-grade, insulated windows with laminated glass and exterior insect screens. The installed windows in the headquarters buildings at all six sites were not as specified. We found inferior, residential-grade window frames that operated with difficulty and appeared to be easily damaged. Many window frames did not contain glass and, if glass was installed, it was single-pane, non-laminated glass. In addition, none of the required insect screens were installed at any of the six sites. At 4 of the 6 sites, the windows were not only lesser quality, but many were smaller than required. At 3 of the 6 sites, window installation was poor with large gaps between the rough openings in the wall and the installed window frame. One window at Garm Ser was installed with a gap so large that the window had to be supported by rocks (see photo 10).

Photo 10: Poorly Installed Window Supported by Rocks at Garm Ser Site

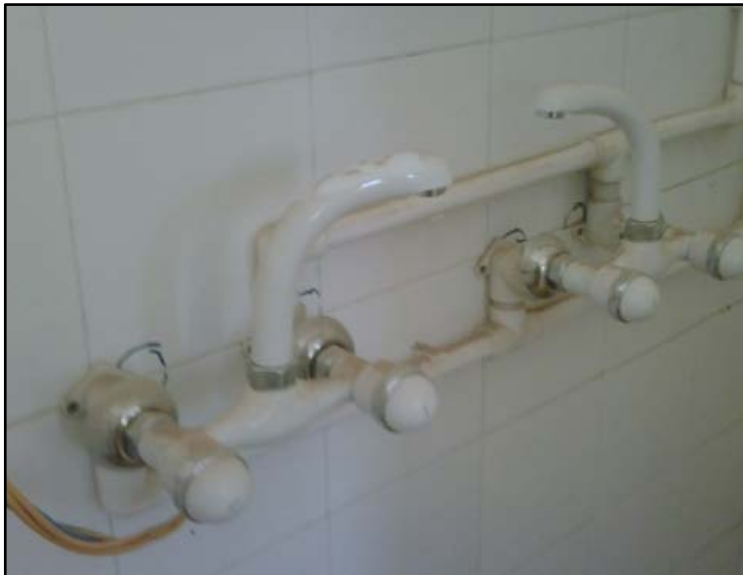
The contract required that all faucets be chrome-plated brass with a single mixing lever. We found that at the four sites where faucets were installed, none met the specification requirements. At two of the sites, dual-handle residential-grade plastic faucets were installed. Chrome-plated faucets were installed at the other two sites, but they appeared to be residential grade and also had two handles. At all four sites, the installed faucets did not appear to be able to withstand the heavy use expected at this type of facility. Photo 13 shows the plastic, "goose-neck" faucets that do not meet contract requirements, installed at Takha Pul.

Photo 13: Residential Grade "Goose-Neck" Faucets at Takha Pul Site

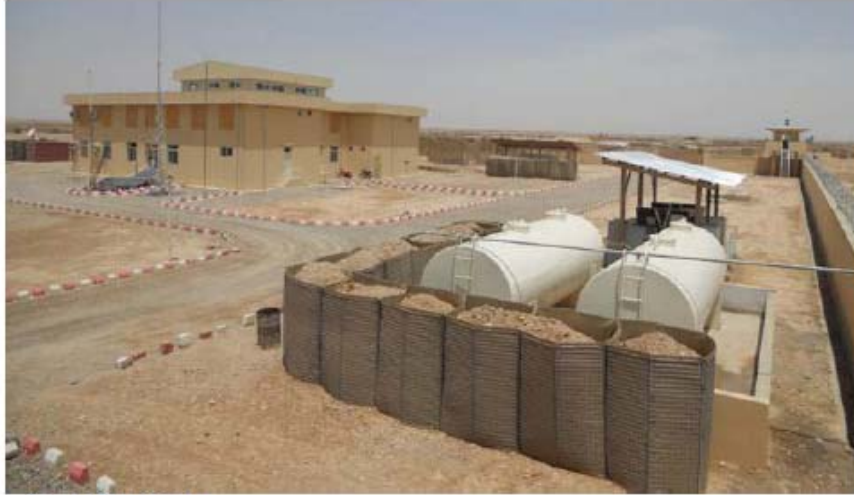
Figure 1 Nahri Saraj

- Electrical wiring runs into building through a knocked out hole in the exterior wall.
- Under sized and poorly constructed storm water outlet structures.
- Inadequate exhaust hood, approximately 1/8th of the required size, powered by an extension cord. Cooking area with propane cylinders located in the kitchen. Cook top constructed on the wrong wall.
- Per contract requirement, the contractor provided, and the USACE reviewed and approved a detailed landscape plan that included trees, grass, shrubs, and sidewalks. However, the project was accepted and turned over with no landscaping installed.

USACE Comment: All deficiencies have been corrected and the facility has been turned over for use.
