**OFFICE OF THE SPECIAL INSPECTOR GENERAL
FOR AFGHANISTAN RECONSTRUCTION**

**INSPECTION OF HABIB RAHMAN SECONDARY SCHOOL
CONSTRUCTION PROJECT IN KAPISA PROVINCE:
DESIGN AND SAFETY ISSUES REQUIRE ATTENTION**

October 26, 2009

SUBJECT: SIGAR Inspection Report 10-3: Inspection of Habib Rahman Secondary School
Construction Project in Kapisa Province: Design and Safety Issues Require Attention

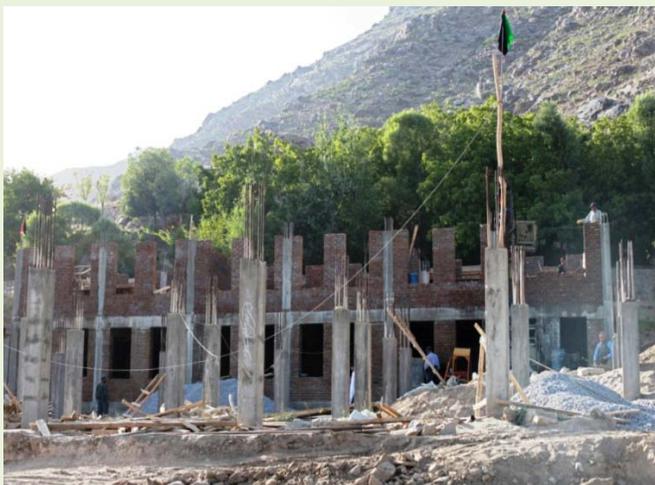
- Unfinished work left over from earlier construction at the site continues to cause major design and safety issues. The contract does not require the removal of this unfinished structure and currently there are no plans to have it demolished. SIGAR believes this abandoned construction site occupies valuable space which could be used for a number of other purposes. Additionally, it presents an unsafe environment for school children.

View of new school construction obscured by the unfinished and unusable structure of a previous construction project. (Photo provided by SIGAR)

That the Commander, U.S. Forces-Afghanistan and Commander, Kapisa PRT initiate a follow-on CERP project to correct the design and safety deficiencies noted in this report.

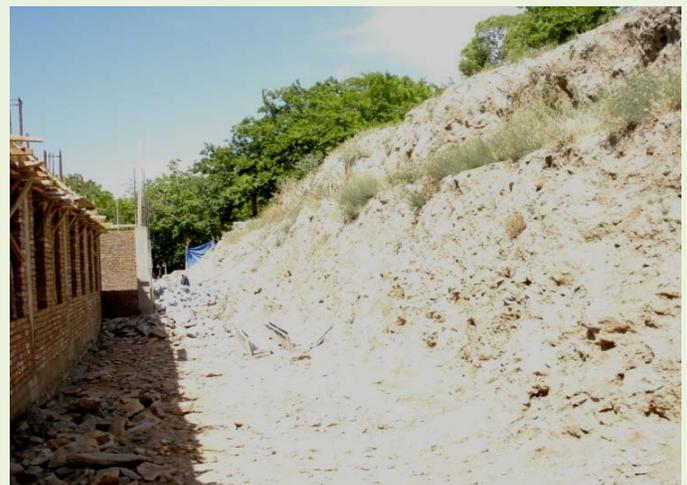
- The lack of a reinforced retaining wall and the associated earth removal work needed in the rear of the school which is adjacent to the base of a hill could pose a hazard to building occupants from potential rock and mud slides. This problem resulted from the decision to build the new school behind the unfinished work site which required the contractor to excavate a portion of the hill to make room for the new construction. The existing masonry security perimeter wall is insufficient to protect the school from debris falling from the hillside.

View of the limited offset distance from the base of a hill which could be subject to rock and mud slides. (Photo provided by SIGAR)

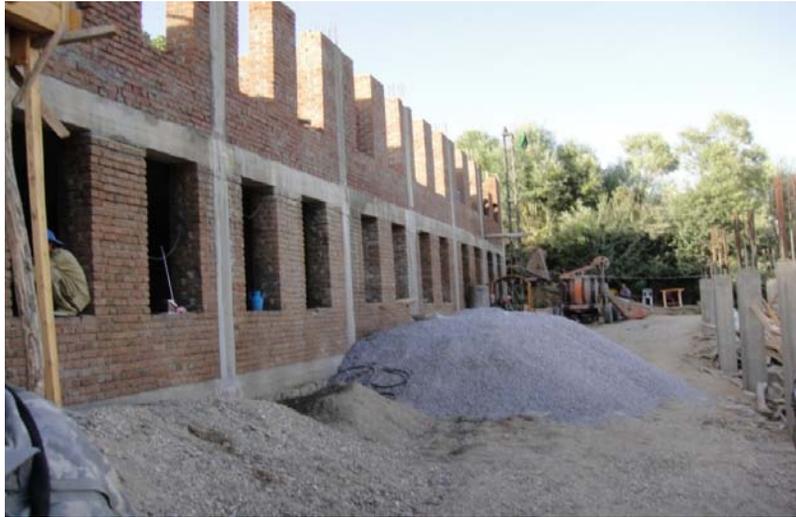
Site Photo 1: View of partially completed school building. Portions of the previously constructed and abandoned structure can be seen to the right of the photograph. (Photo provided by SIGAR)

At the time of SIGAR's inspection in August, it was estimated that the project was almost 50 percent complete (see Site Photo 1) with significant progress made on the main school building and perimeter wall.

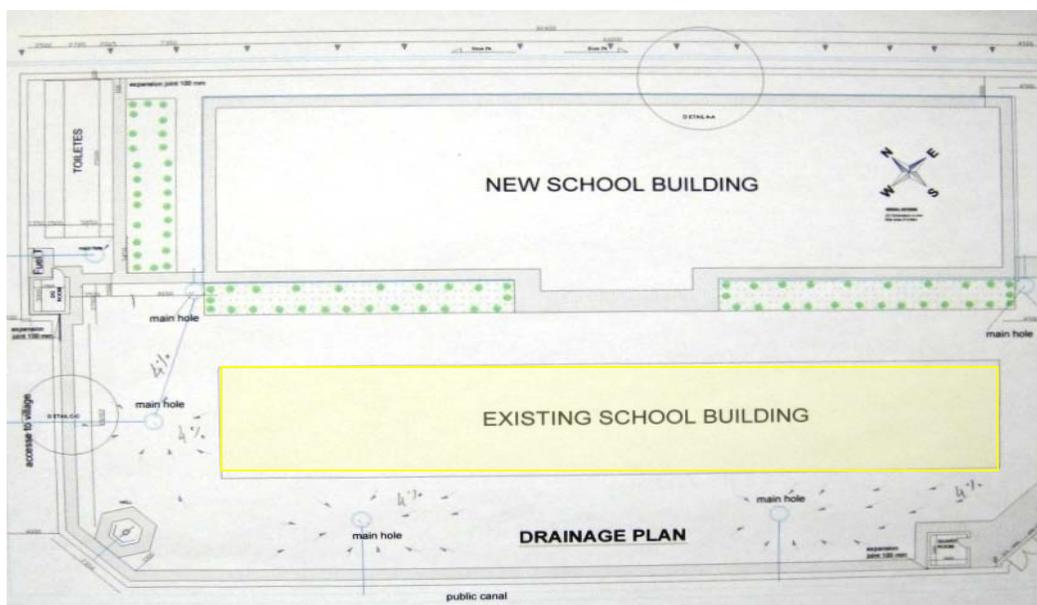
Figure 2: Design Plan for the Habib Rahman Secondary School which builds around a previously built, unfinished structure (shaded in yellow) rather than demolishing it. (Illustration provided by Kapisa PRT)

The first design flaw in the project noted by SIGAR focuses on the existence of a previously constructed but unfinished and unsafe structure (see Site Photo 2 and Figure 2) which occupies valuable land that could be used for a number of other purposes.³ When the Kapisa PRT became involved in the school project in the summer of 2008 following discussions with the Provincial Director of Education, it was decided that the existing structure should not be used because of concerns regarding its structural soundness. The current contract did not require the removal of this prior construction and PRT officials noted that they do not have plans to remedy this problem. SIGAR could not determine why this unfinished and unsafe structure was not demolished as part of the initial project proposal except for statements from the current PRT staff which indicated that local authorities believed they could make use of the unfinished structure. Despite attempts to

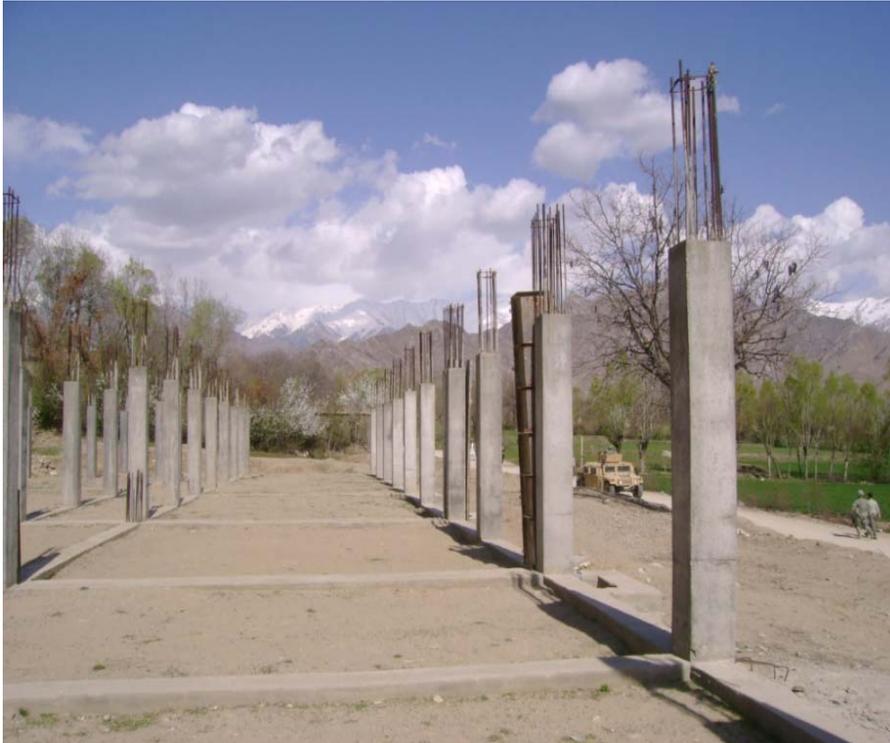
locate documents that would provide definitive details on the construction of this partially built structure, SIGAR could find no records or individuals who could offer further information on this decision.

Site Photo 2: View of earlier school construction that was left unfinished and abandoned for several years. This abandoned structure stands directly next to the main road leaving no clearance room for further construction in front. (Photo provided by Kapisa PRT)

RECOMMENDATION 1: SIGAR recommends that the Commander, U.S. Forces-Afghanistan and Commander, Kapisa PRT initiate a follow-on CERP project to correct the design deficiencies noted in this report to include demolishing the previously built but unusable structure on the school compound, and constructing a protective retaining wall at the rear of the new school in place of the perimeter wall. (page 6 of SIGAR report)

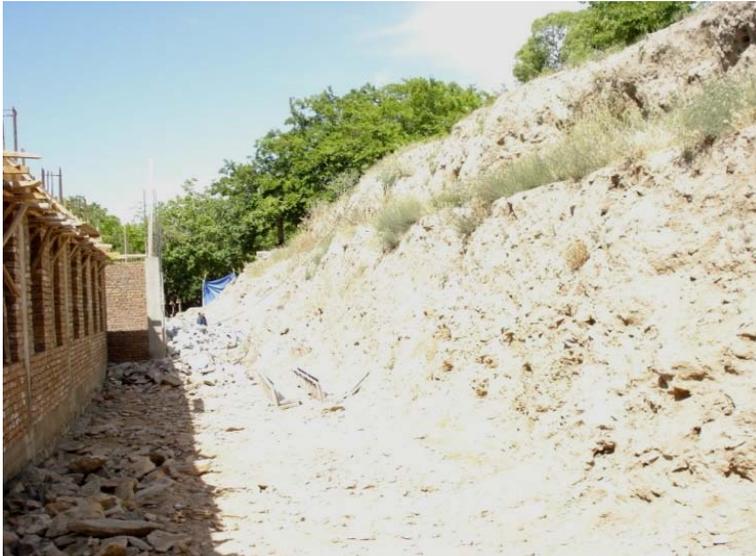
In order to make room for the present construction site, which had to be built around the abandoned construction site, the contractor was required to excavate an extensive area 50 meters into the adjacent hillside. For this reason, the new school building was constructed adjacent to an embankment at the base of a steep hillside (see Site Photo 3) near a flood plain that was graded in order to accommodate the new school compound.

SIGAR found that the rear of the school building abuts the base of the embankment slope of the hill leaving a space of less than 2 meters between the perimeter wall and the rear wall of the school. Proper construction of a retaining wall requires masonry reinforcement of the wall as well as a footing constructed to the correct dimensions. Such a retaining wall is needed to hold back potential rock and mudslides. SIGAR considers the absence of a retaining wall to be a significant deficiency because the embankment slope may be subject to rock and mud slides that could pose an imminent hazard to building occupants.

SIGAR believes that the Kapisa PRT Quality Assurance Representative responsible for the planning of this project should have insisted on the construction of an appropriately designed retaining wall, as well as additional site grading to ensure an adequate offset between the school and the embankment was included in the original statement of work. These steps would have produced an adequate and safe school structure that would protect its occupants from landslides and other site hazards.

Site Photo 3: View of the embankment at the rear of the school building. Although a perimeter wall was subsequently built, it does not afford the structural protection against mud and rockslides that a properly designed and constructed retaining wall would provide. (Photo provided by Kapisa PRT)

KP PRT RESPONSE: Kapisa PRT partially concurs with information provided in this SIGAR Report. A follow-on project should be implemented for correcting the rear security wall and potentially adding a retaining wall and proper drainage. The reinforced concrete frame of the previously built school was left on site at the request of Nijrab government officials and local shura leaders. The engineers of the area are working to get funding to build a small community center and/or library on the site that may use some of the existing structure.

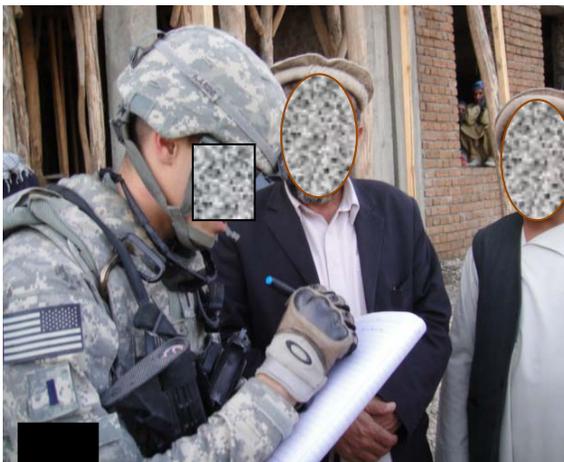
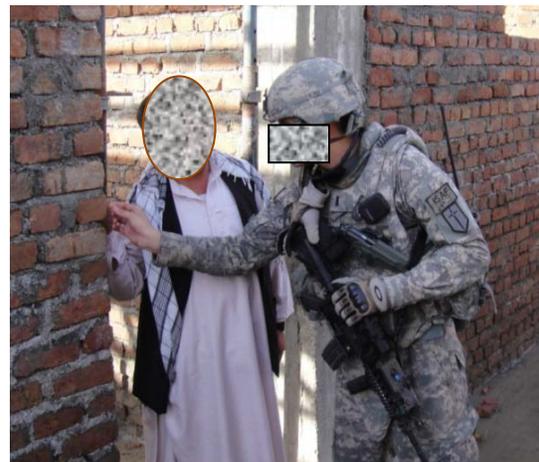
At the time of SIGAR’s June site visit, key project management documents such as a proper Quality Control Plan, work schedules, and routine progress reports from the contractor, were largely missing from the project file. SIGAR believes the Kapisa PRT’s management of the project, as well as the conduct of its Quality Assurance Program, were inadequate during the initial stages of this project as evidenced by the numerous contracting missteps discussed earlier. However, SIGAR found that both the contractor’s and the PRT’s quality review systems improved significantly between our June and August site visits as a result of increased interest in the project on the part of the PRT. Improvements implemented during this time period included regularly scheduled visits by the PRT’s Quality Assurance Representative (see Site Photos 4 and 5 below), the filing of daily progress reports by the contractor, and development of a “coaching” program to teach proper construction techniques to work crews by the PRT. These improvements have largely corrected the earlier performance problems observed by SIGAR for the new school construction.

Site Photos 4 and 5: View of Kapisa PRT’s Quality Assurance Representative inspecting construction progress. (Photo provided by SIGAR)
