SIGAR 17-08 Inspection Report

Herat University Women's Dormitory: Generally Well Constructed, but Instances of Contract Non-Compliance Should Be Addressed

OCTOBER
2016

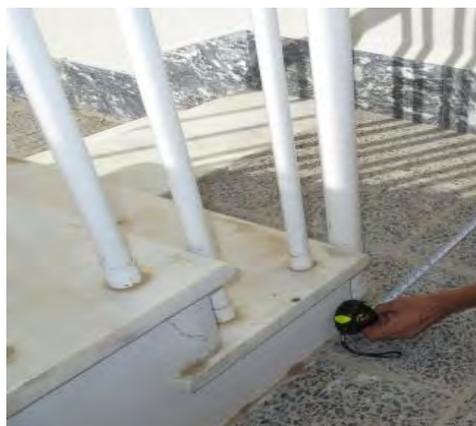
Photo 2 - Narrow Stairway Landing Area

- **Improperly constructed stairway landing area and library ramp:** The contract required adherence to the IBC, which requires a minimum 48-inch landing area at the base of the library's emergency exit stairway.¹¹ When we measured the landing area, it was 29 inches (see photo 2). Further, the design drawings required Poushang Construction to construct the library ramp with no more than an 8 percent slope, but we found that the ramp had a 14 percent slope. The narrow emergency exit landing area and steep ramp slope could present safety issues for occupants exiting the facility during an emergency situation.

USFOR-A and USACE partially concurred that the narrow emergency landing area and steep ramp slope for the library should be corrected, stating that USACE is in the process of reviewing the circumstances surrounding the narrow emergency exit landing area and steep ramp slope. USACE noted that it will provide us the results within 90 days. USACE added that the library, two exit ways, and emergency landing area are sufficient for emergency egress and should not present significant safety issues for occupants exiting the facility during an

emergency situation. The narrow emergency landing area and steep ramp slope for the library will remain in our first recommendation until we receive and evaluate the results of USACE's review as to why the stairway landing areas and ramp slopes did not meet construction requirements.

1. **Direct Poushang Construction to correct all instances of contract non-compliance identified in this report, specifically the failure to install flashing-light fire alarms, the missing exit signs and smoke detectors, and the improperly constructed library stairway area and ramp; and**
2. **In coordination with the Herat University O&M activity, examine the dormitory's fire extinguishers to determine whether they are faulty, and, if they are, replace them.**

e. Improperly constructed stairway landing area and library ramp. Partially-Concur. We are in the process of conducting a review of the circumstances surrounding the stairway, landing and ramp. We will conclude our review within 90 days and provide SIGAR the results. We would like to point out, in the meantime, the library has two exit ways, and the emergency landing would only be used for the second floor, which also has 2 exit ways. It is not a large library and will not have a large population at any given time. Presently, the exits provided, in our opinion, are sufficient for emergency egress and should not present significant safety issues for occupants exiting the facility should an emergency situation arise. We will expedite or review in order to resolve this issue as soon as possible.

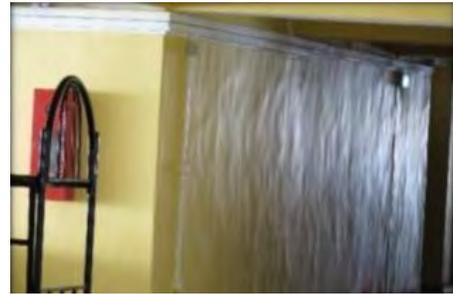
Photo 3 - Poorly Finished Interior Wall

- **Poorly finished interior walls:** The contract's technical specifications stated that the dormitory's plaster surfaces, such as interior walls, should be brought to a true, even finish with a rod or straightedge to fill surface defects. However, during our inspection, we found that the plaster surface on the interior walls had noticeable waves (see photo 3). Although the condition of the walls does not pose a health or safety risk, it shows a lack of compliance with contract requirements. In the June 5, 2014, Weekly Quality Deficiency Tracking List, USACE noted the poorly finished interior walls. At the time of our inspection, we found no evidence that corrective action had been taken.

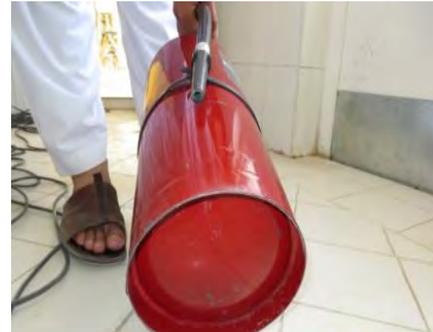
Photo 4 - Fire Extinguisher with No Manufacture Date

- **Fire extinguishers have duplicate serial numbers and do not have the required external markings:** Poushang Construction installed 36 dry chemical fire extinguishers in the dormitory even though the contract only required the installation of 29 of these extinguishers. Two additional fire extinguishers were installed on each of the dormitory's three floors, and two fire extinguishers were kept as spares in the electrical room. However, we found that all of the extinguishers, manufactured by Buckeye Fire Equipment Company, a U.S. company, were missing the embossed manufactured date, typically located on the bottom of the cylinder (see photo 4). Every Buckeye fire extinguisher's manufacture date should be embossed on the bottom of the cylinder, and this embossed date does not scratch or fade. We also found that 30 of the fire extinguishers had the same serial number, instead of each fire extinguisher having its own unique serial number as required by the manufacturer. The lack of the required manufacture date and duplicate serial numbers raises the concern that these fire extinguishers may not work in the event of a fire.

USFOR-A and USACE partially concurred with our recommendation to conduct an examination of the dormitory's fire extinguishers to determine whether they have the required manufacture dates and stamps. In its comments, USACE stated that it approved the fire extinguisher submittals, and "the brand selected, Buckeye, is the best quality of fire extinguisher imported to Afghanistan." USACE added that it had no indication that the fire extinguishers did not fully meet contract requirements. However, during our June-July 2015 site inspection, we observed that although the fire extinguishers appeared to be the Buckeye brand, some did not appear to meet Buckeye's standards, which raises concerns that the extinguishers may not be authentic. For example, some of the extinguishers did not have an embossed manufacture date.

To verify the information in USACE's comments, we conducted two additional site visits in September 2016 and inspected all of the fire extinguishers in the dormitory to assess their authenticity. We used Buckeye's product brochures for identifying a counterfeit fire extinguisher as guidance for our assessment. We found that none of the 36 installed fire extinguishers had the manufacture date stamped on the bottom. In addition, we found that 30 of the 36 fire extinguishers had the same serial number, instead of each extinguisher having a unique serial number, which is Buckeye's standard. As a result, we determined the fire extinguishers did not meet the manufacturer's requirements and therefore may not be authentic.

USFOR-A and USACE did not concur with our recommendation to determine whether the fire extinguishers without the required manufacture dates and stamps are faulty, and, if they are, replace them. In its comments, USACE stated that "The fire extinguishers will need to be inspected by the user and Operations and Maintenance activity to determine if the fire extinguishers still meet the original contract requirements and if they remain operational." USACE added that the dormitory's O&M activity will need to replace any fire extinguishers found to be defective. Based on USACE's response and the results of our September 2016 site visits, we revised our recommendations regarding the fire extinguishers. We now recommend that USFOR-A and USACE, in coordination with the Herat University O&M activity, examine all of the dormitory's fire extinguishers to determine whether they are faulty, and, if they are, replace them.
