SIGAR

Office of the Special Inspector General
for Afghanistan Reconstruction

May 19, 2016

SUBJECT: Mission Response to Draft SIGAR Alert Letter titled
"Structural Damage at Educational Facility S145A"
(SIGAR- SP-124)

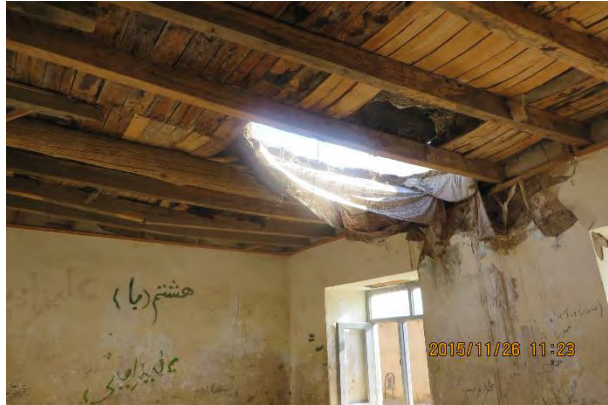
Structural failures observed in photos taken at the facility indicate that the roofing and walls at educational facility S145A cannot withstand heavy loads, such as snowfall, heavy rains, and other natural events. It appears that the continued lack of proper maintenance paired with improper construction methods likely caused these deficiencies. Continued roof and wall deterioration could endanger students and staff. Photos 1 and 2 shows damaged roofing at the facility.

Photo 1 - Failed Roof Structure at Educational Facility S145A

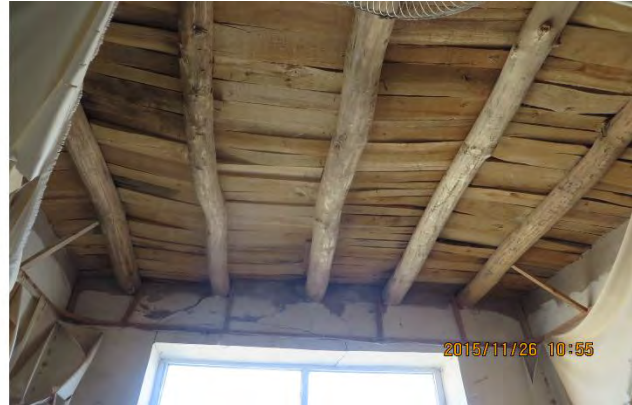
Photo 2 - Deteriorating Roof Structure at Education Facility S145A

Note: Sagging wood planks supporting mud roof and plastic sheeting.

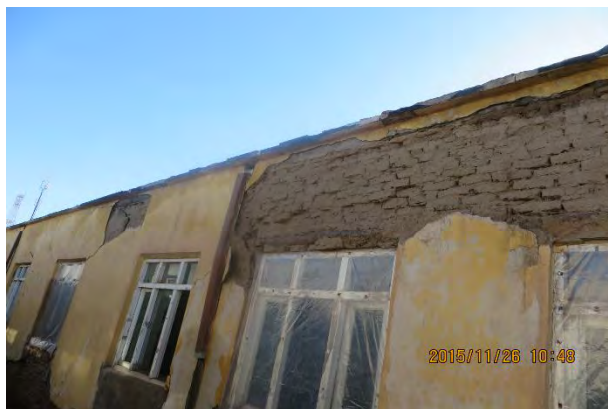
SIGAR engineers also observed that the CMU installations do not follow general engineering standards and that the CMUs had improper mortar bedding, jointing, masonry reinforcing, and control and expansion joints. The particular construction methods employed at this facility, combined with poor workmanship, could cause walls to fail and lead to additional structural damage at the facility. The conditions at this facility are now so poor that, in some places, bricks are crumbling and falling out of the walls of the classroom building. A seismic event or continued deterioration over time will likely cause the structure to fail. Failing to address this issue and a persistent lack of maintenance will further weaken the classroom's structural integrity and may speed collapse. Photos 3 and 4 show improper CMU installations at the facility.

Photo 3 - Cracked and Crumbling Exterior Wall at Educational Facility S145A

Note: Exposed brick deteriorating.

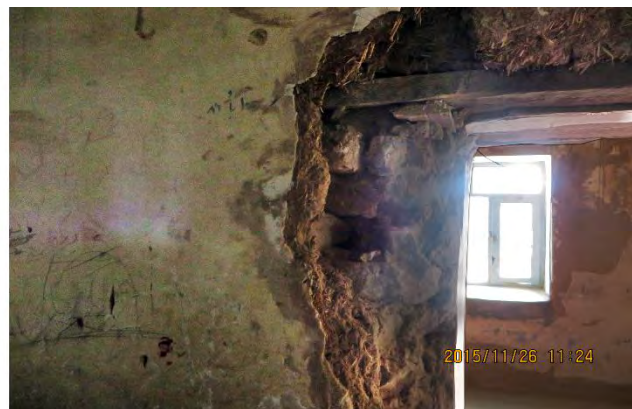
Photo 4 - Crumbling Interior Wall at Educational Facility S145A

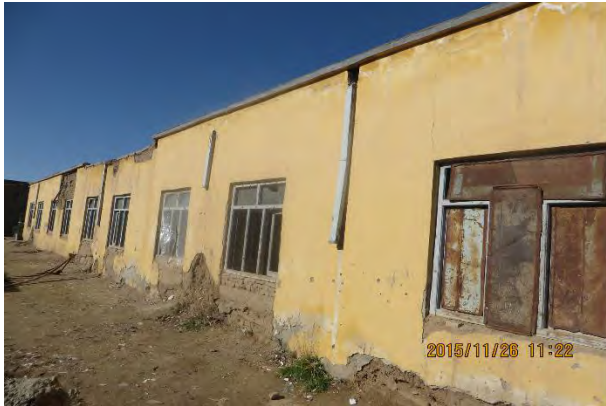
Furthermore, missing downspouts across the facility result in concentrated water flow on the walls and foundation. Exposure to rain and other weather effects will continue to damage plaster and erode mud walls at the facility. If left unattended, erosion will further deteriorate the strength of the facility's walls, as seen in Photos 5 and 6.

Photo 5 – Missing Downspouts at Educational Facility S145A

Source: SIGAR, November 26, 2015
Note: Missing downspouts cause erosion of the wall.

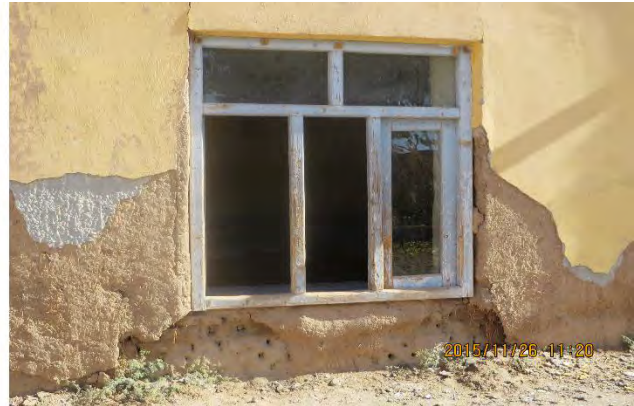
Photo 6 – Plaster Failure at Educational Facility S145A

Source: SIGAR, November 26, 2015
Note: Plaster failure causes further structural deterioration.

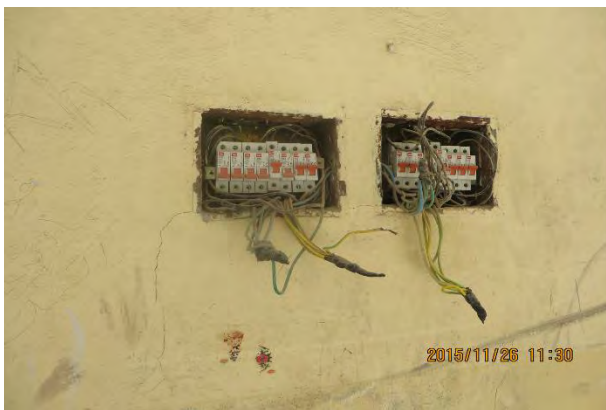
Electrical deficiencies at the facility also pose serious hazards that could endanger occupants. Improper wiring connections and installations and exposed circuit breakers and wiring are a potential shock and fire hazard, as seen in Photos 7 and 8.

Photo 7 – Exposed Circuit Breakers at Educational Facility S145A

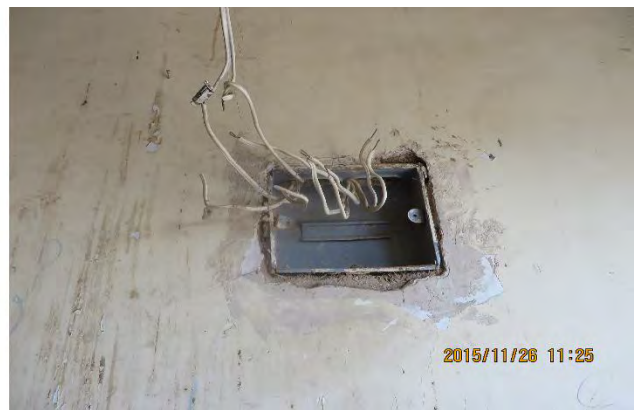
Photo 8 – Exposed Wiring in an Electrical Box at Educational Facility S145A

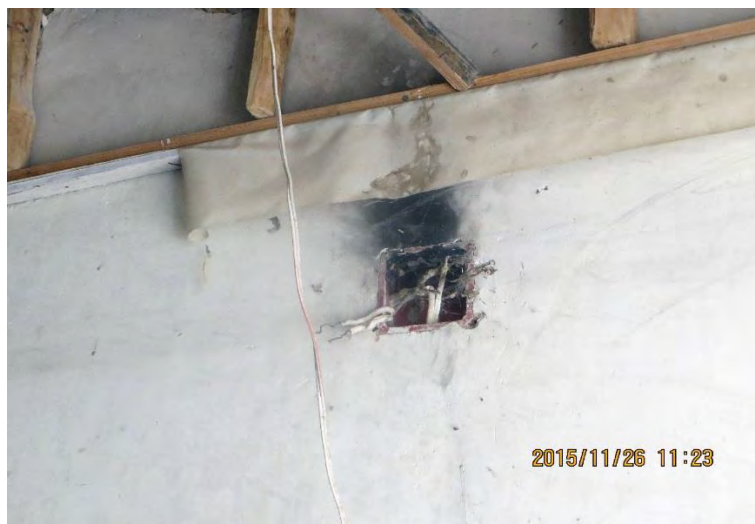
Photo 9 shows indications of damage from a previous electrical fire at facility S145A.

Photo 9 – Indications of Previous Electrical Fire at Educational Facility S145A

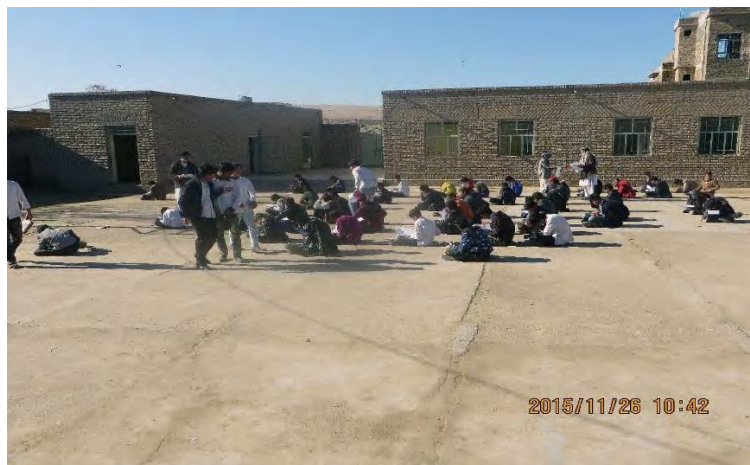
Structural failures at facility S145A may also be impacting the delivery of educational services in the classroom facilities. Photo 10 shows students receiving educational instruction outside of the facility's building while sitting on the ground. During an interview, the school's general manager stated that, "The building constructed by the USAID is in the very poor physical condition and unusable. If this building is not repaired, it would completely collapse."⁶

Photo 10 – Students Taking Exam Outdoors on School Grounds
