**SIGAR Inspection 13-4**

**KUNDUZ AFGHAN NATIONAL POLICE  
PROVINCIAL HEADQUARTERS: AFTER  
CONSTRUCTION DELAYS AND COST  
INCREASES, CONCERNS REMAIN ABOUT  
THE FACILITY'S USABILITY AND  
SUSTAINABILITY**

**JANUARY  
2013**

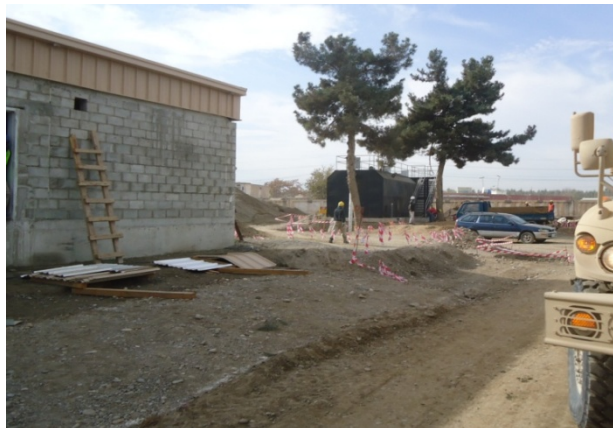
(SIGAR Photo 11/15/2012)

Sewage Treatment Plant (black) at Elevated Portion of Provincial Police Headquarters Compound

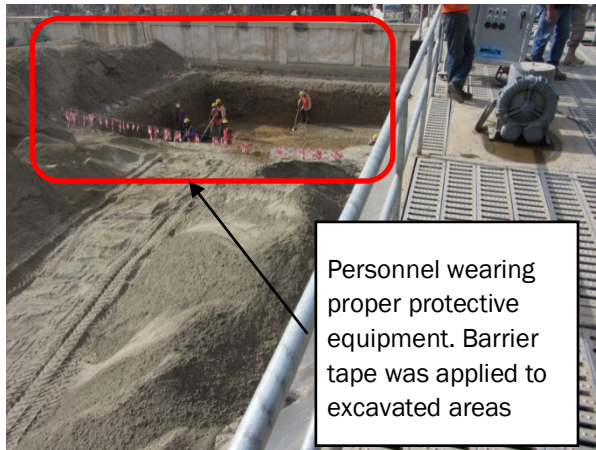
**Figure 2 - Over-Excavation of Sewage Filter Beds**

Personnel wearing proper protective equipment. Barrier tape was applied to excavated areas

Source: SIGAR Photo 11/15/2012 (taken from the top of the sewage treatment plant)

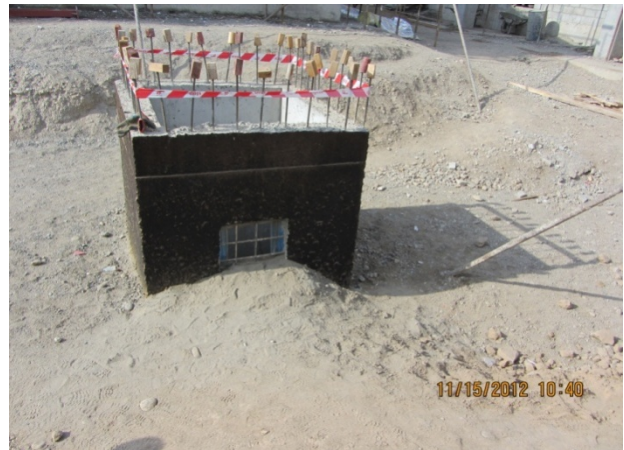
**Figure 3 - Sewer Manhole Construction**

According to contractor representatives, the ANP Provincial Headquarters project was approximately 50 percent complete when we visited the site on November 15, 2012.<sup>6</sup> Most of the buildings were structurally complete, although construction was ongoing and no buildings, to date, were occupied by the end user. No significant structural construction deficiencies were noted and site grading and drainage also appeared adequate at this point in the construction project. Site occupational safety practices were also adequate based on our observations. Personnel were observed to be wearing proper protective equipment. Barrier tape was applied to excavated areas (see figure 2). Some small excavations were observed as in figure 2. We also observed that most underground utility piping, conduit, and manholes had been installed. However, some building sewer connections had not been made to the nearest manhole (see figure 3), and no electrical cabling

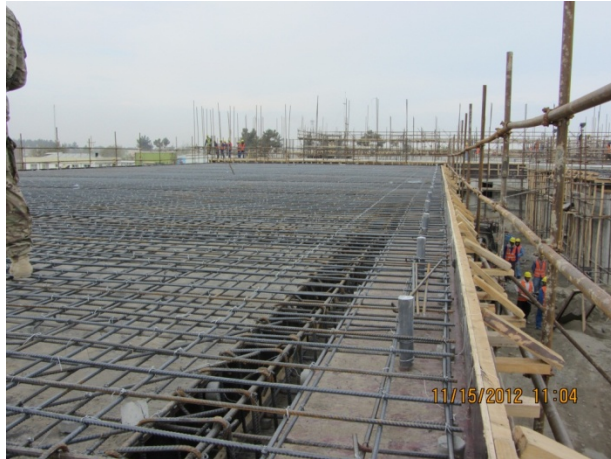
**Figure 6 - Roof Rebar Placement for Concrete Pour for Open Bay Barracks**

had yet been delivered to the job site. Nevertheless, in our view, these are not significant issues since the project is only 50 percent complete. Construction was continuing on, among other things, the dining facility and barracks (see figures 4 and 5). The quality of the concrete and steel construction appeared to meet contract specifications (see figures 6 and 7).

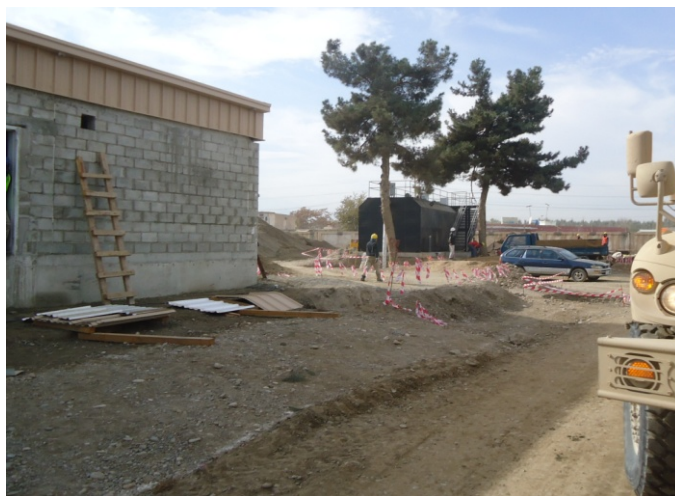
**Figure 8 - Distant View of the Sewage Treatment Plant**

To address site waste water, a sewage treatment plant<sup>10</sup> (see figures 8 and 9) has been installed near the main entry control point on the northwest corner of the project site—one of highest elevation points for the site. Based on discussions with site personnel and USACE-TAN, installation of the sewage treatment plant at this higher elevation is based on the need to discharge the treated sewage effluent into a municipal storm and sewage drain system located outside the site along the northwest corner.

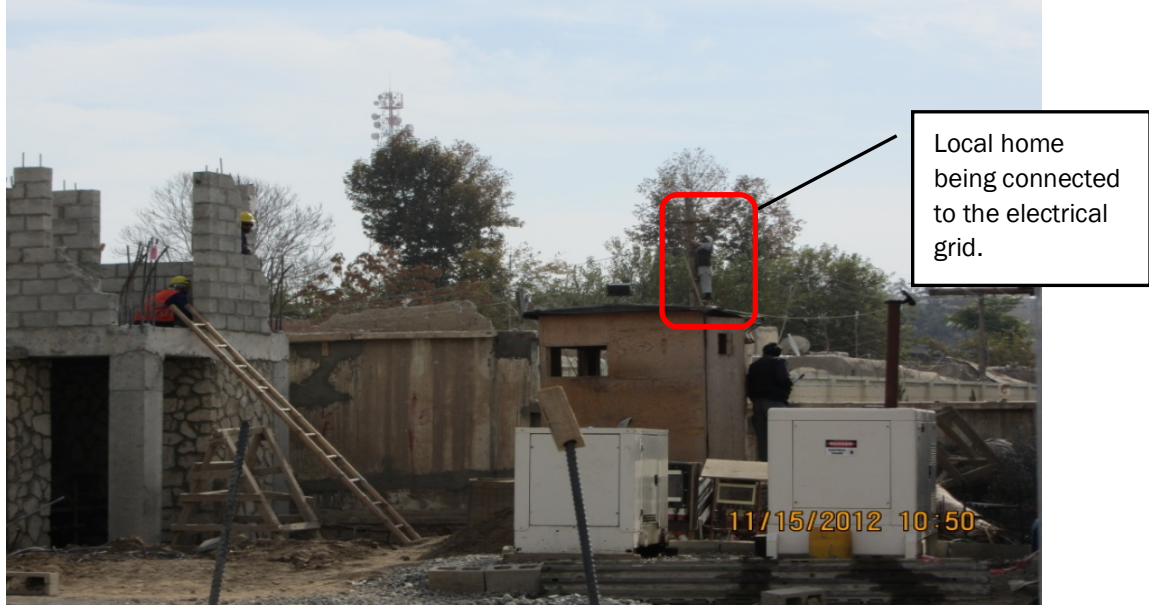
**Figure 11 - Evidence of Local Electrical Grid Adjacent to Site**

A potentially cheaper option that would not require fuel to be delivered on a regular basis to the generator would be to connect the site to the local electrical grid. Distribution power lines for the area's electrical grid exist along the western perimeter of the site and we observed a local home being connected to that grid (see figures 1 and 11). In discussion with USACE-TAN representatives, they informed us that a decision had been made at the beginning of the project to not connect to the local grid, because it would not support the requirements of the site facilities, and the variability in voltage and frequency of electricity from the local grid could damage the site electrical equipment. However, fuel requirements for the diesel generator will be extremely costly, raising questions about USACE-TAN's decision to forgo connecting the site to the local electrical grid, or determining other economical means to provide back-up electrical power.

- 2. Review the decision made at the start of the project to not connect the site to the local electrical grid and, as part of the review, conduct a cost-benefit and technical analysis. The review should factor the high costs to purchase and deliver fuel to the site for the electrical generator, the capability of the local grid to provide adequate power for the site facilities and equipment, and the need for a back-up site electrical system. Based on the results of this review, if connection to the local power grid is not feasible, install a back-up site generator or otherwise provide an appropriate back-up electrical power system to prevent loss of electricity across the site when the primary generator is not working.**
- 3. Award an operation and maintenance contract at project completion to ensure that the facility is appropriately maintained once occupied.**
