SIGAR Inspection 13-2

**WARDAK PROVINCE NATIONAL POLICE
TRAINING CENTER: CONTRACT
REQUIREMENTS GENERALLY MET, BUT
DEFICIENCIES AND MAINTENANCE ISSUES
NEED TO BE ADDRESSED**

**OCTOBER
2012**

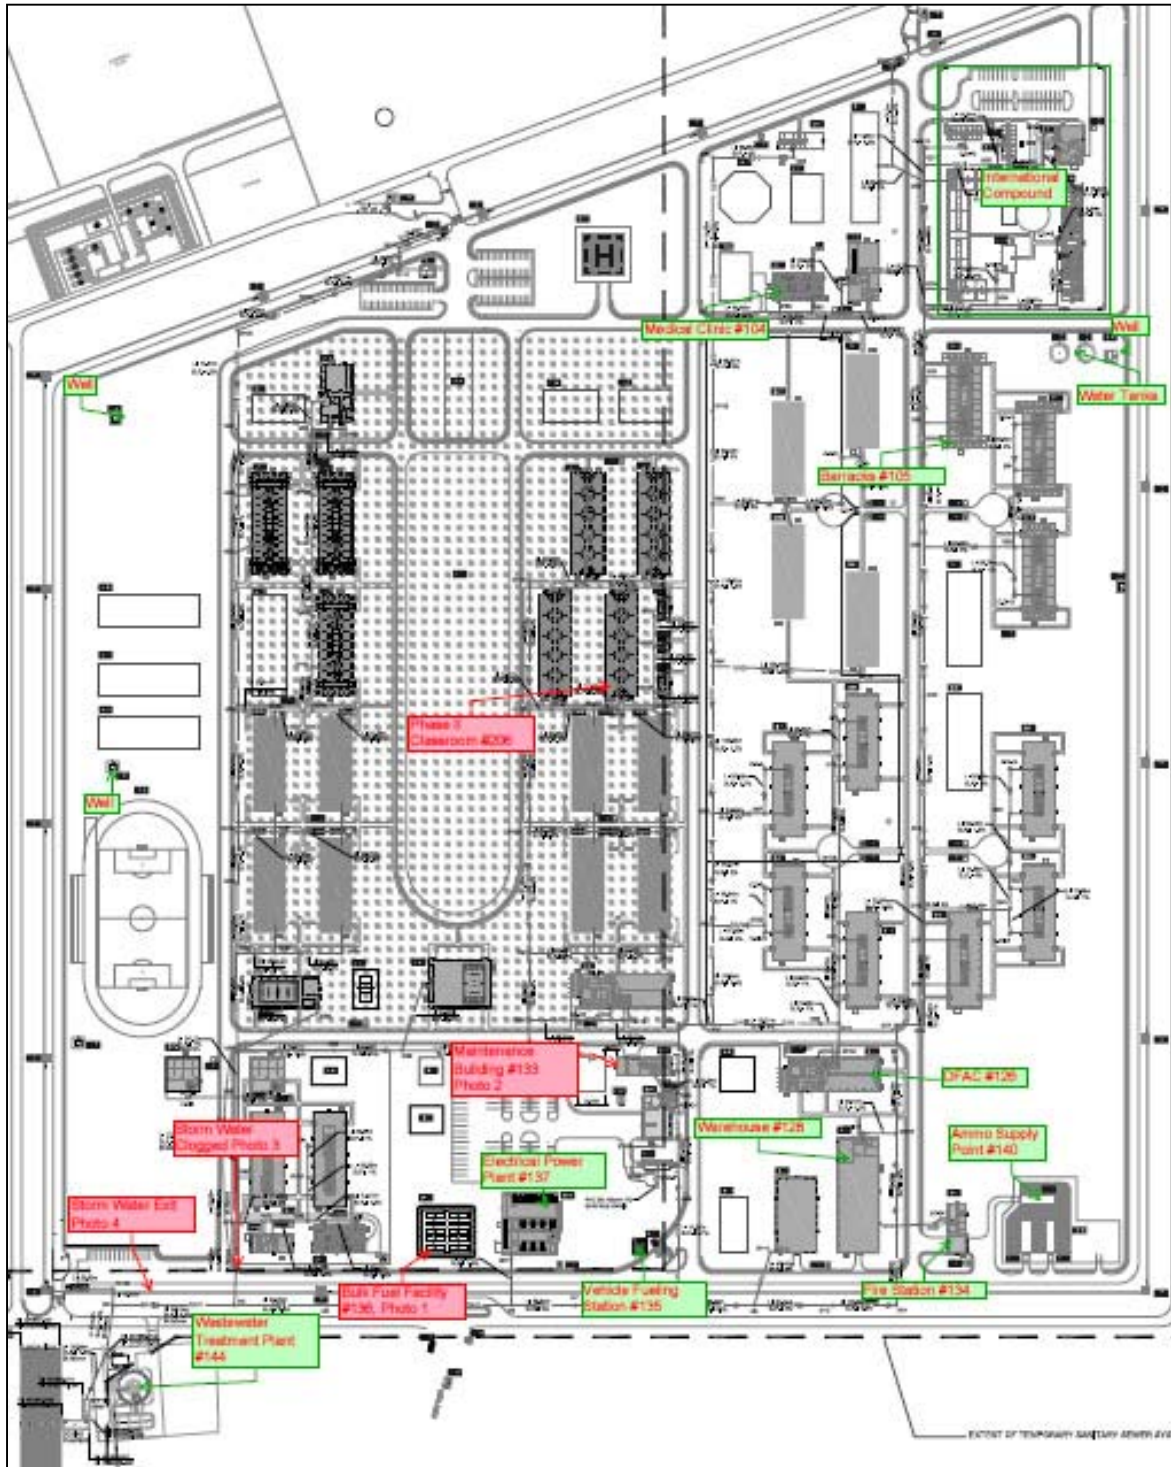
Figure I - Map of Site with Locations Inspected by SIGAR

Source: USACE-TAN. Note: We highlighted in green the locations that appeared to meet contract specifications. Locations highlighted in red indicate areas where SIGAR noted quality or maintenance issues.
