SIGAR 16-16 Inspection Report

Afghan Ministry of Defense Headquarters:
\$154.7 Million Building Appears Well
Built, but Has Several Construction Issues
that Should Be Assessed

FEBRUARY
2016

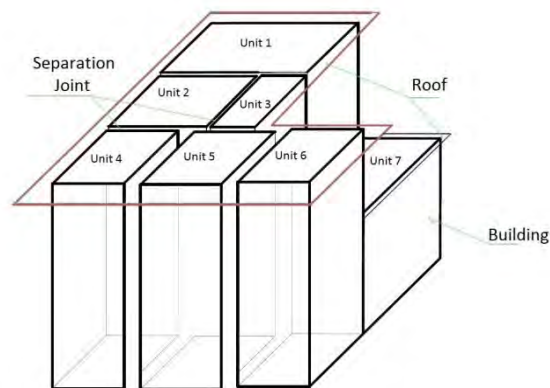
Figure 2 - Headquarters Building Sections Schematic

The separation joints between the building sections—designated as expansion joints in the design documents—are complete breaks or separation in the floors, walls, and ceilings that divide the overall building into smaller discrete sections. Those individual sections are designed to handle larger vertical displacement, building settlement, materials shrinkage, and seismic activity. When properly constructed, separation joints create a continuous break line from the foundation up to and through the roof. Each building section needs a distinct structural system on each side of the continuous break line. For example, two walls or columns and beams may be required, whereas only one would be provided in a building that did not require separation joints. No structural system can span across the separation joint or the purpose of the joint is lost. Lastly, non-structural systems must be installed with flexible connections across the separation joints. Figure 2

presents a schematic of the seven sections of the headquarters building and the separation joints that run from the foundation up to and through the roof. In addition to including separation joints to reduce damage to a structure during an earthquake, the building can include stronger walls, columns, and beams. Stronger walls called shear walls were included in this building. However, Building Unit 2 shear walls will not be strong enough to prevent the movement from exceeding the maximum allowable by the American Society of Civil Engineers standard 7.

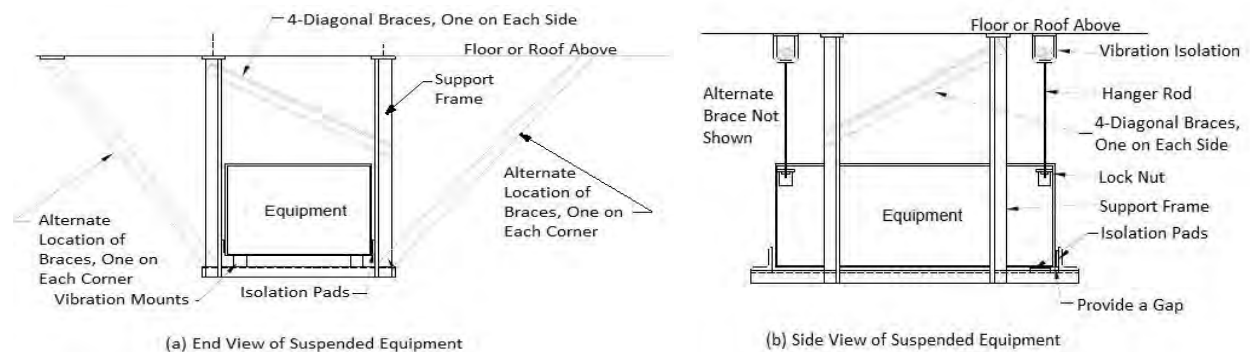
Figure 3 - Typical Seismic Restraints for Suspended Equipment

During our May 27, 2015, inspection, we found building equipment that did not have lateral bracing. Task orders 0030 and TG06 required that electrical and structural building standards, as defined in the Department of Defense's Unified Facilities Criteria, be followed in constructing the headquarters building.⁵ Based on the Unified Facilities Criteria, lateral bracing must be provided for items supported from the ceiling or floor above. Figure 3 shows typical seismic bracing, based on the Unified Facilities Criteria, used for equipment suspended from the ceiling or floor above.

As shown in figure 3, diagram (a) presents an end view of suspended equipment and shows lateral bracing both inside and outside of the support frame holding the equipment. Diagram (b) presents a side view of suspended equipment and shows the lateral bracing inside of the support frame, as well as the hanger rods tied into the ceiling or floor above and the suspended equipment.

4. Assess the integrity of lateral bracing, anchorage, isolation, and energy dissipation of all equipment for compliance with the contract's seismic requirements, and make deficient items compliant with the requirements.

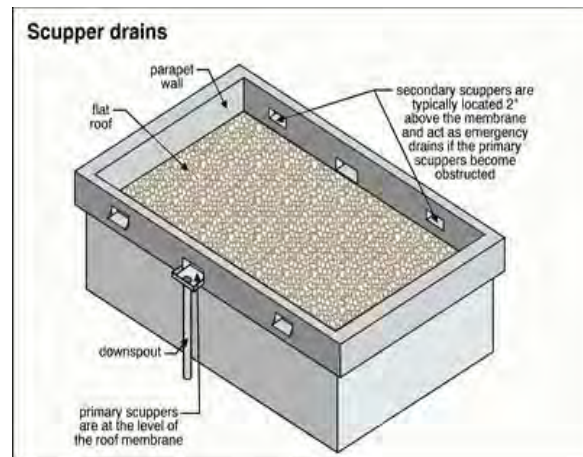
Figure 4 - Example of Secondary Drain for a Roof with Parapet Walls

During our 2015 inspections, we found that the roof was not designed or constructed in accordance with the contract and code requirements for roof drainage.⁷ For example, we found that the installed roof drains measured 3 inches, not the 4 inches in diameter required by the ITSI engineers' revised calculations. In addition, secondary drains, known as scuppers, were not installed. The contract design documents required—as does the building code—a secondary emergency overflow for roofs with a parapet wall (see figure 4 showing examples of secondary emergency roof drains).⁸ Otherwise, if storm water is trapped on the roof behind the parapet walls, it could (1) damage the ventilation and heating/cooling equipment that is roof mounted on 4-inch high platforms, and (2) allow water to enter the roof access doors and flood the building causing damage to equipment and interior finishes.
