**ANP District Headquarters Facilities in Helmand and
Kandahar Provinces Have Significant Construction
Deficiencies Due to Lack of Oversight and Poor
Contractor Performance**

SIGAR Audit-11-3

ANP District Headquarters Facilities In Helmand and Kandahar Provinces Have Significant Deficiencies Due to Lack of Oversight and Poor Contractor Performance

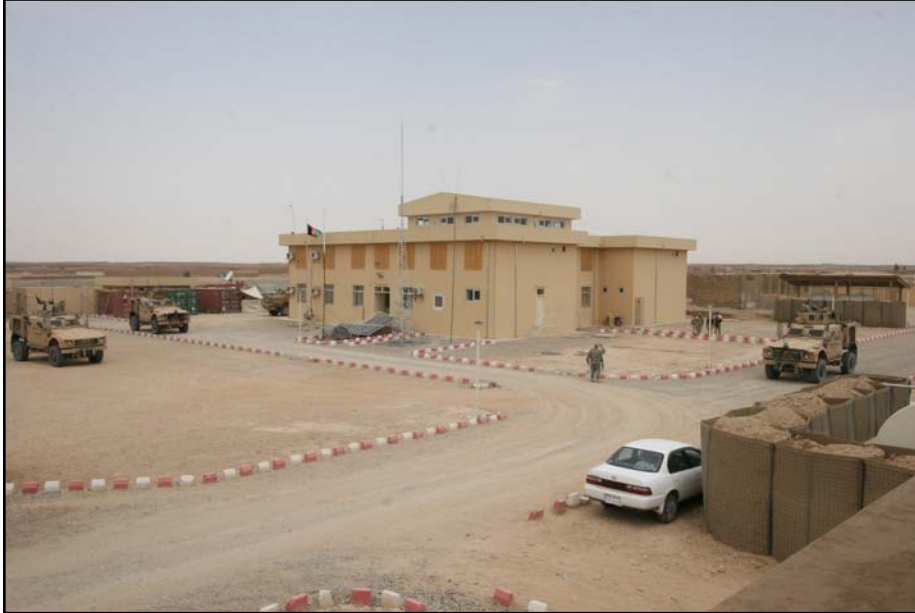
Photo 1: Nahri Saraj ANP District Headquarters

According to the contract documents, each completed compound should contain a central headquarters building that includes prisoner holding cells, administrative offices, billeting areas, food preparation and dining facilities, latrines with showers, and an armory. Each compound should also have a perimeter wall, four guard towers, a well house, water storage tank, and fuel storage for both diesel and propane. Photo 1 shows one completed facility at Nahri Saraj.
