# SIGAR

BRIDGES IN BAGHLAN PROVINCE,  
AFGHANISTAN: SIX OF EIGHT BRIDGES  
CONSTRUCTED OR REHABILITATED BY DOD  
REMAIN IN GENERALLY GOOD, USABLE  
CONDITION; TWO APPEARED TO HAVE  
STRUCTURAL ISSUES NEEDING ATTENTION

**SEPTEMBER 2018**

SIGAR 18-70-SP

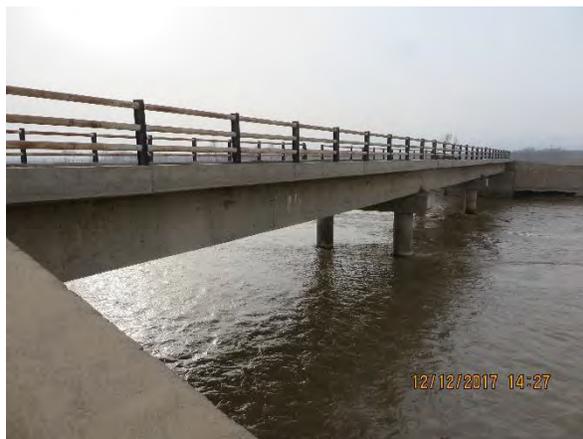
Bridge 1 was one of the more costly CERP bridge projects in Baghlan province. This beam-style, 70-meter concrete vehicle bridge was completed in early 2010 for a cost of \$554,825. It replaced an existing, deteriorating bridge at the same location.<sup>6</sup> When we visited the site, we observed vehicle traffic. A local MRRD official stated that the local communities relied on the bridge to facilitate local commerce and it connected the village to major metropolitan areas. However, we found that the bridge’s embankment wall had deteriorated significantly, and its retaining walls had structural damage, which may be a potential safety hazard.

near the bridge. SIGAR notified the Afghan government about the poor condition of the bridge.<sup>78</sup> Photo 1a shows the span of the bridge and Photo 1b shows one of the structural concerns we observed at the embankment wall.

Photo 1a: Bridge Spanning a Wide River.

These structural issues—possibly compounded by inadequate maintenance, seismic events, strong river currents, and continuous stress on the approach road—created safety concerns for users on or

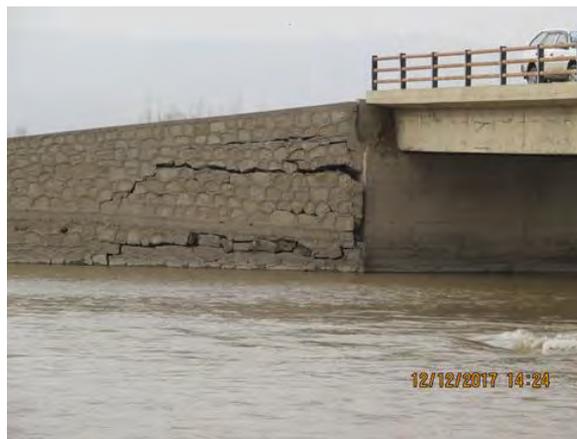
Photo 1b: Significant Cracks along Embankment Wall

<sup>8</sup>According to DOD's response to SIGAR's May 22, 2018 alert letter, a preliminary analysis of project documents by DOD engineers indicated that the reinforced concrete bridge and the wing walls are independent structures that meet at the bridge abutment. Erosion of soil from behind the wing walls could negatively impact the approach road and cause it to settle, but will not impact the bridge itself. However, to avoid further erosion, DOD's engineers agreed that the wing walls should be repaired. U.S. Forces-Afghanistan (USFOR-A) agreed to notify the Afghan government of the safety concern raised in the alert letter.

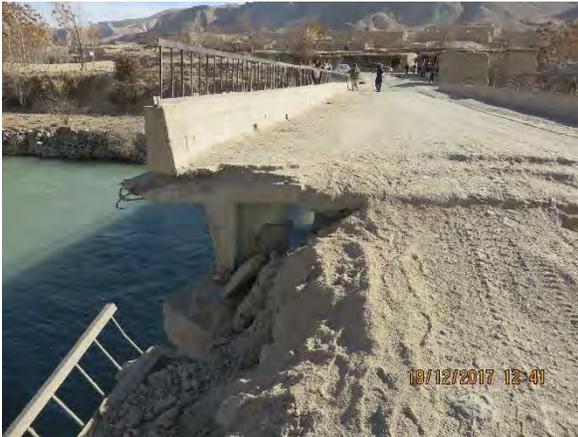
Bridge project 2 included the rehabilitation of an existing, damaged bridge. In October 2011, USFOR-A awarded a CERP-funded contract for \$16,180 to make limited repairs to the bridge to maintain a major supply route and to ensure the local population's access to services and markets. According to project records, USFOR-A terminated the project in early 2012, due to issues with the local population. Available documentation showed that the repairs were 82% complete when the project was terminated and \$13,267.60 was paid to the contractor for work completed. During our visit in December 2017, the bridge's superstructure, approach, retaining walls, and traffic safety rails showed a lack of maintenance, potentially pose a danger to users, unless needed maintenance is undertaken by the Afghan government. Given the condition of the bridge, we issued an alert letter to DOD and notified the Afghan government regarding the need for repairs to ensure the safety of people on or near the structure.<sup>9</sup> Photo 2 shows the unmaintained, eroding approach. Photo 2b shows a freight truck leaving the bridge.

Photo 2a: Eroding Bridge Approach

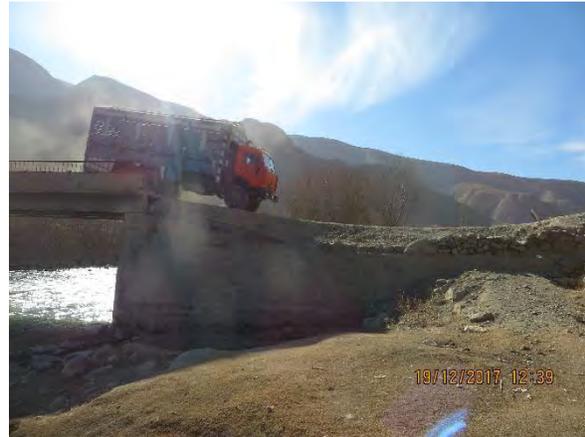
Photo 2b: Freight Truck Leaving the Bridge

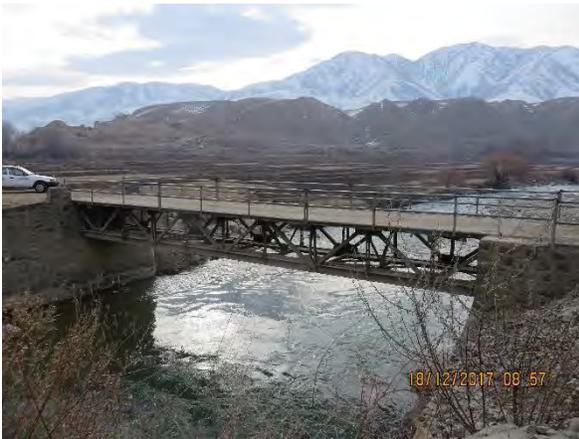
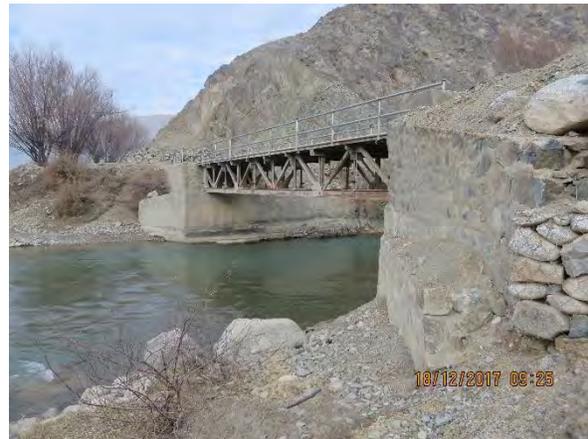
Bridge 3 was constructed in June 2012 for \$66,446, and allows foot and vehicular traffic access to and from local markets. When we visited the bridge, we found the metal truss bridge to be in generally good condition, showing no visible indication of damage. Individuals we spoke with, including a local government official with responsibility for infrastructure maintenance, stated that the bridge was very useful and had a positive impact on local commerce. Photos 3a and 3b show the condition of Bridge 3.

Photo 3a: Bridge Project 2 Spanning a River

Photo 3b: Bridge Project 2 from Other Bank

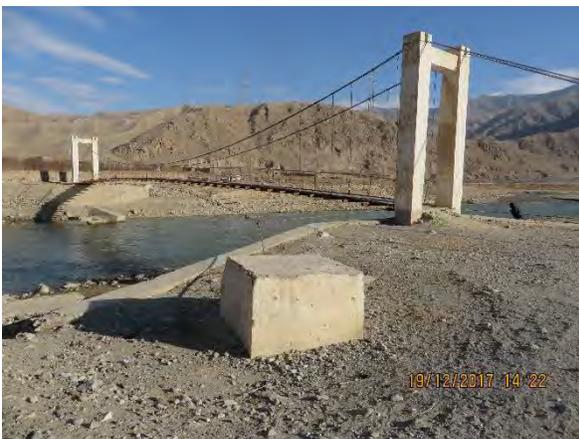
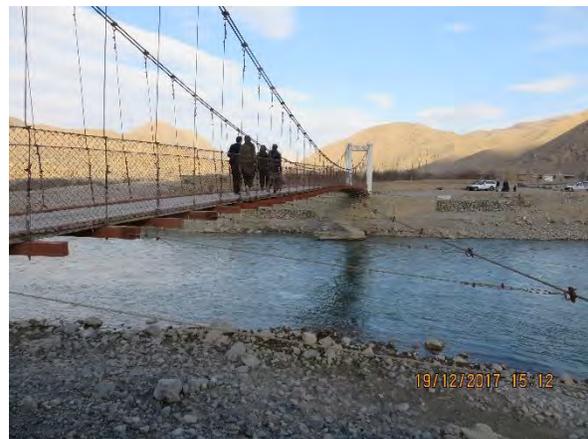
According to CERP documents, rain and snow runoff in early 2012 caused the collapse of a rural pedestrian bridge in Doshi district of Baghlan province. In response, USFOR-A provided \$124,629 in CERP funding to build a new, 100-meter suspension style pedestrian bridge to replace the collapsed structure. When we visited the bridge in December 2017, we found the bridge to be in good condition overall and regularly used by the local community. We did not observe any significant structural concerns on the bridge, the embankment walls, or the bridge cables and their housing blocks. Photos 4a and 4b show Bridge 4.

Photo 4a: Bridge Project 4

Photo 4b: Pedestrians Crossing the Bridge

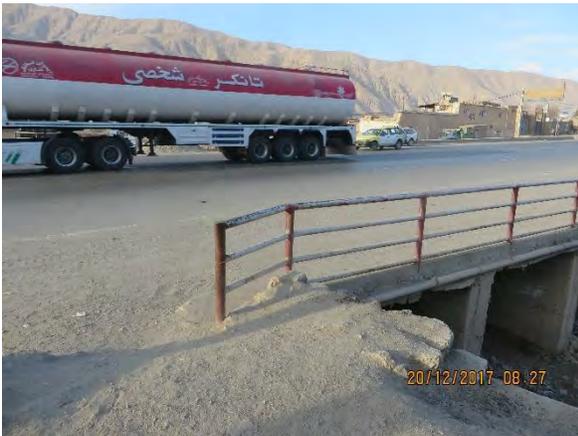
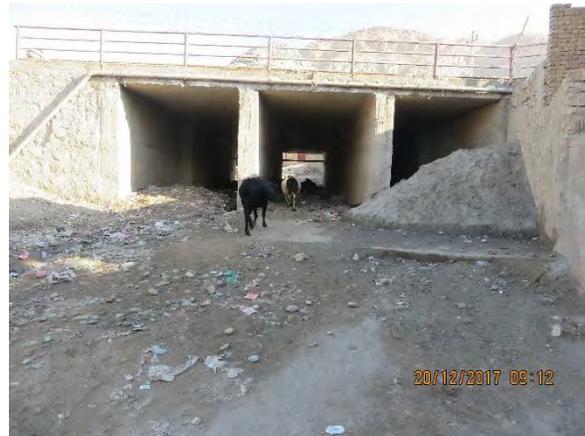
bridge for freight traffic and local community access. Afghan and coalition forces also used the bridge to move combat vehicles. At the time, the existing bridge had been deemed unsafe for vehicular traffic. This is the only bridge we inspected in Baghlan that did not span a river or large body of water, but rather a drainage ditch. We found the bridge to be in heavy use, and in generally good condition with no major structural concerns. Photos 5a and 5b show the condition of Bridge 5.

Photo 5a: Heavy Freight and Personal Vehicles Using the Bridge

Photo 5b: Livestock Crossing Underneath the Bridge.

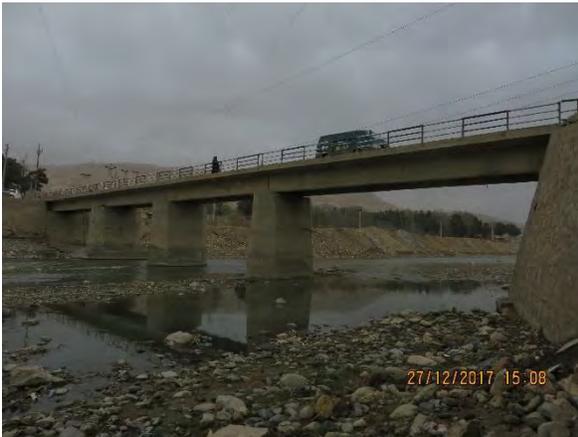
CERP bridges 6 and 7 were funded by a single CERP project that called for the construction of two beam-style vehicle bridges in close proximity to each other in an urban location in Pol-i Khumri district in Baghlan. The bridge projects, one 80-meter bridge and one 28-meter bridge, were completed in December 2013 for a total of \$449,274.<sup>10</sup> When we visited the bridges in December 2017, we found them both to be open and in generally good condition. We also observed significant vehicle, bicycle, and pedestrian traffic crossing both bridges. The bridge pictured in photo 6 is the 80 meter vehicle bridge that crosses a river, and the bridge in photo 7 is the 28 meter vehicle bridge that spans an adjacent canal.

Photo 6: Vehicle Crossing the 80 Meter Vehicle Bridge

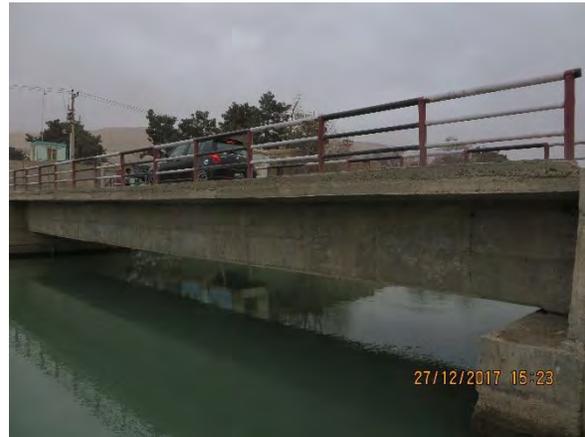
Photo 7: Vehicle Crossing the 28 Meter Vehicle Bridge

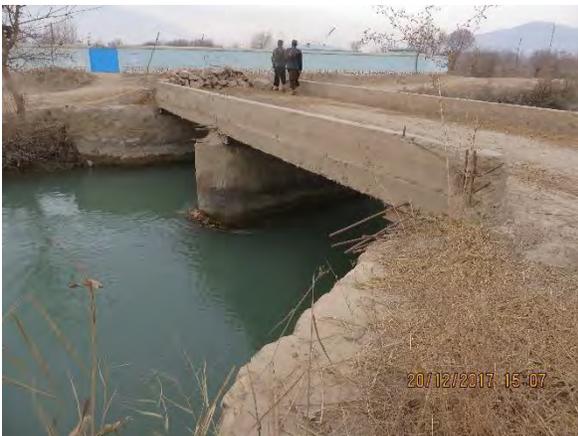
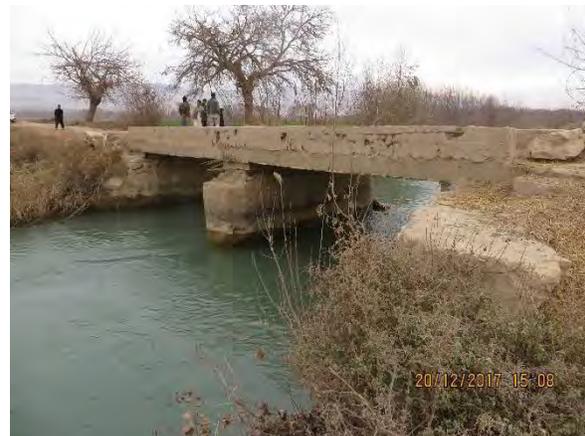
The final CERP bridge project we inspected was completed in November 2012, at a total cost of 8,940. The project rehabilitated an existing bridge that had been damaged by ISAF vehicles. At the time of our December 2017, inspection, the bridge was closed to vehicle traffic due to security concerns and its proximity to a government installation, but was open to pedestrians. We observed pedestrians crossing the bridge, and the bridge appeared to be in generally safe, usable condition. Photos 8a and 8b show the condition of the eighth bridge project.

Photo 8a: Bridge Project 7

Photo 8b: Bridge Project 7 From Far Bank
